CITY OF FORT BRAGG

HOUSING CONDITIONS SURVEY REPORT

AUGUST 2009

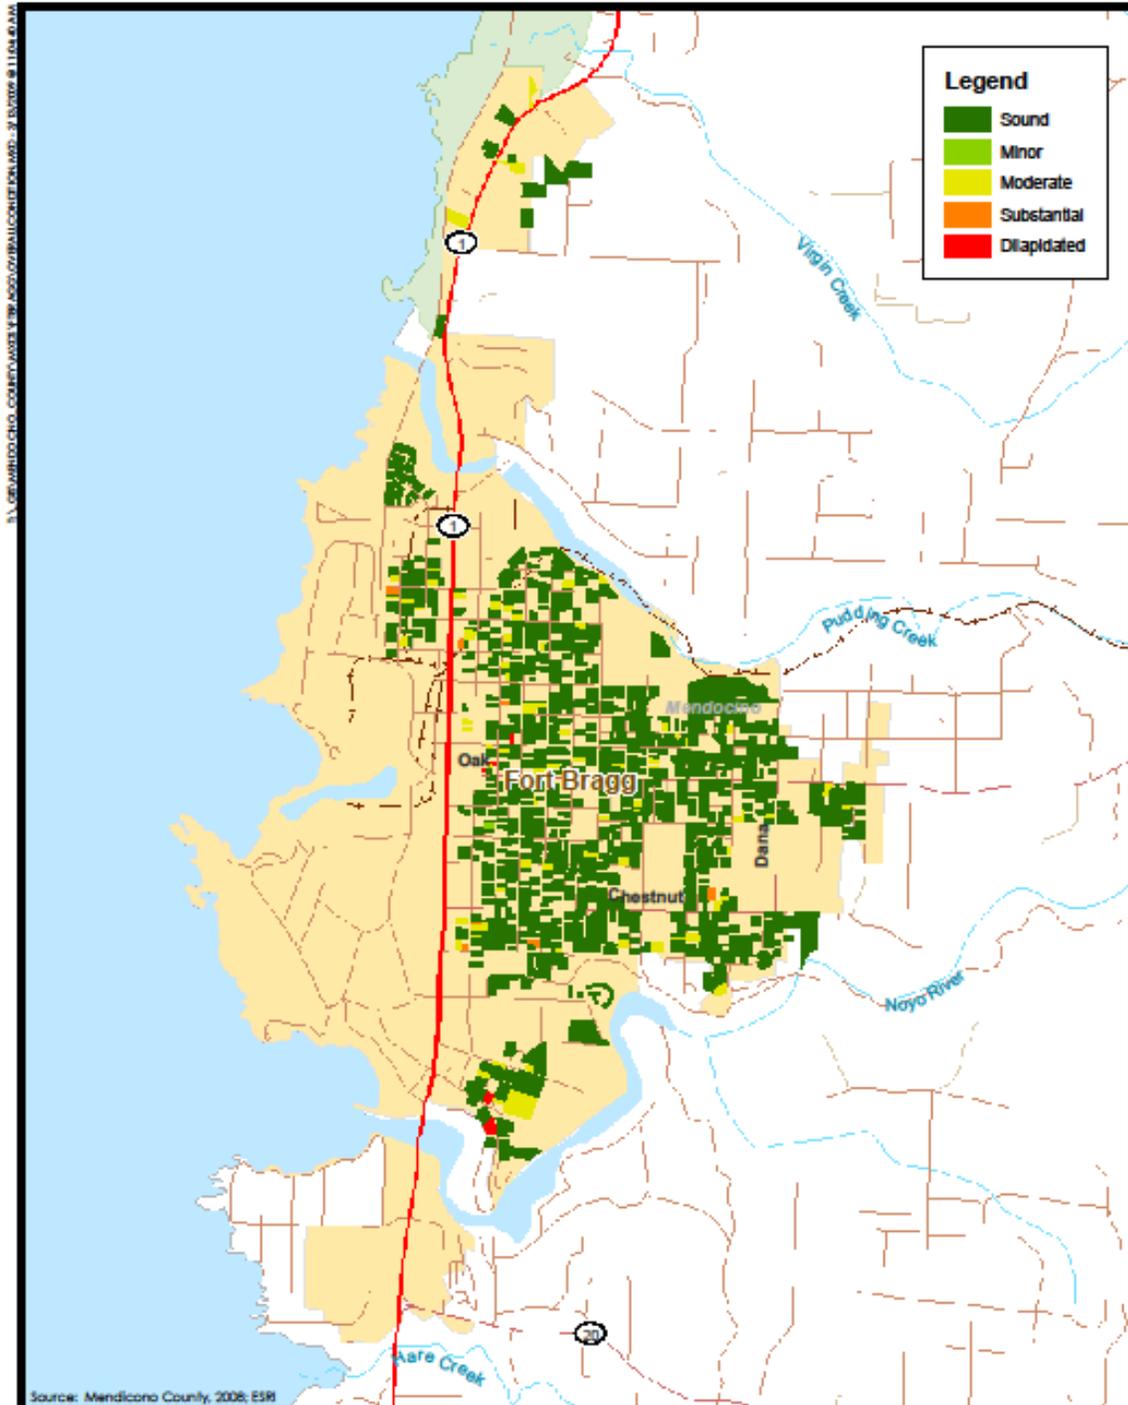
Figure 1
Overall Condition – All Structure Types

The geographic distribution of housing conditions did not reveal any significant concentration of housing in need of repair or dilapidated housing. (Please see Figures 1 and 2.)

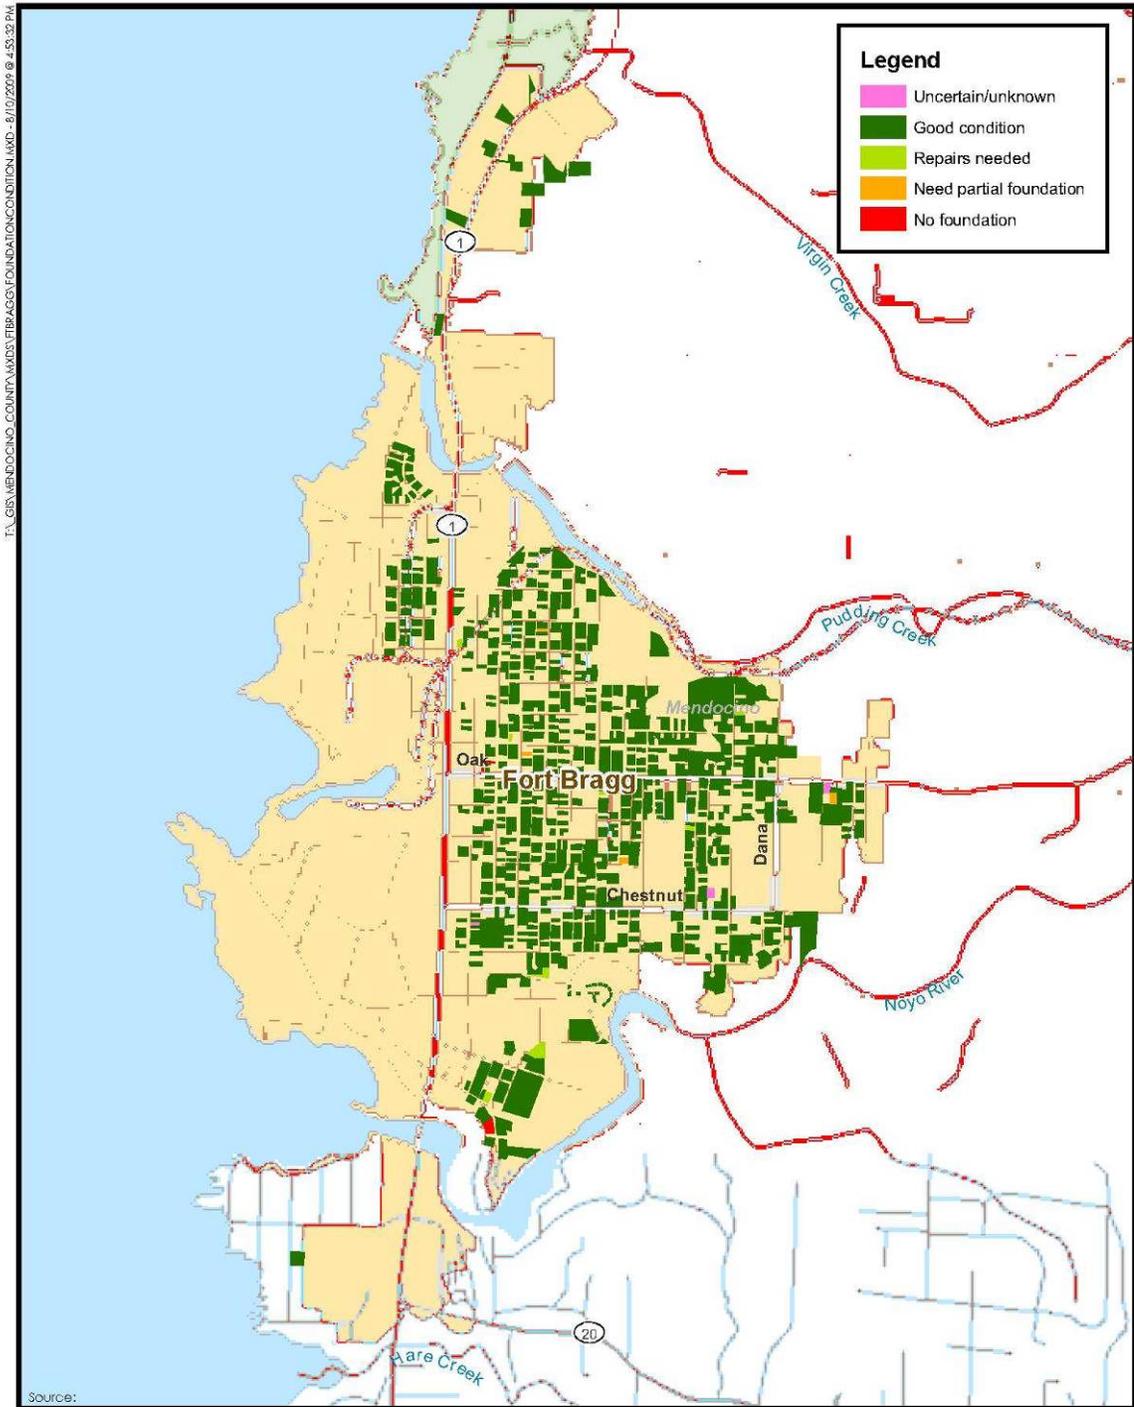
Figure 3 -- Foundation Conditions

Only 22 of the surveyed structures required repairs to the foundation. Ten of these had inadequate foundations. Three structures were noted to have foundation conditions “uncertain/unknown.” These have been excluded from the table below. Sixteen single-family structures had foundation problems, 8 of them substantial. No duplexes required repairs to the foundation and only one multi-family structure required minor repair to the foundation. Six second dwelling units have foundation problems, 2 of them substantial. (Please see Table 5.)

Units requiring foundation repairs were not concentrated in any particular geographic area nor was the severity of repair need higher in any particular section of the City. (Please see Figure 3.)

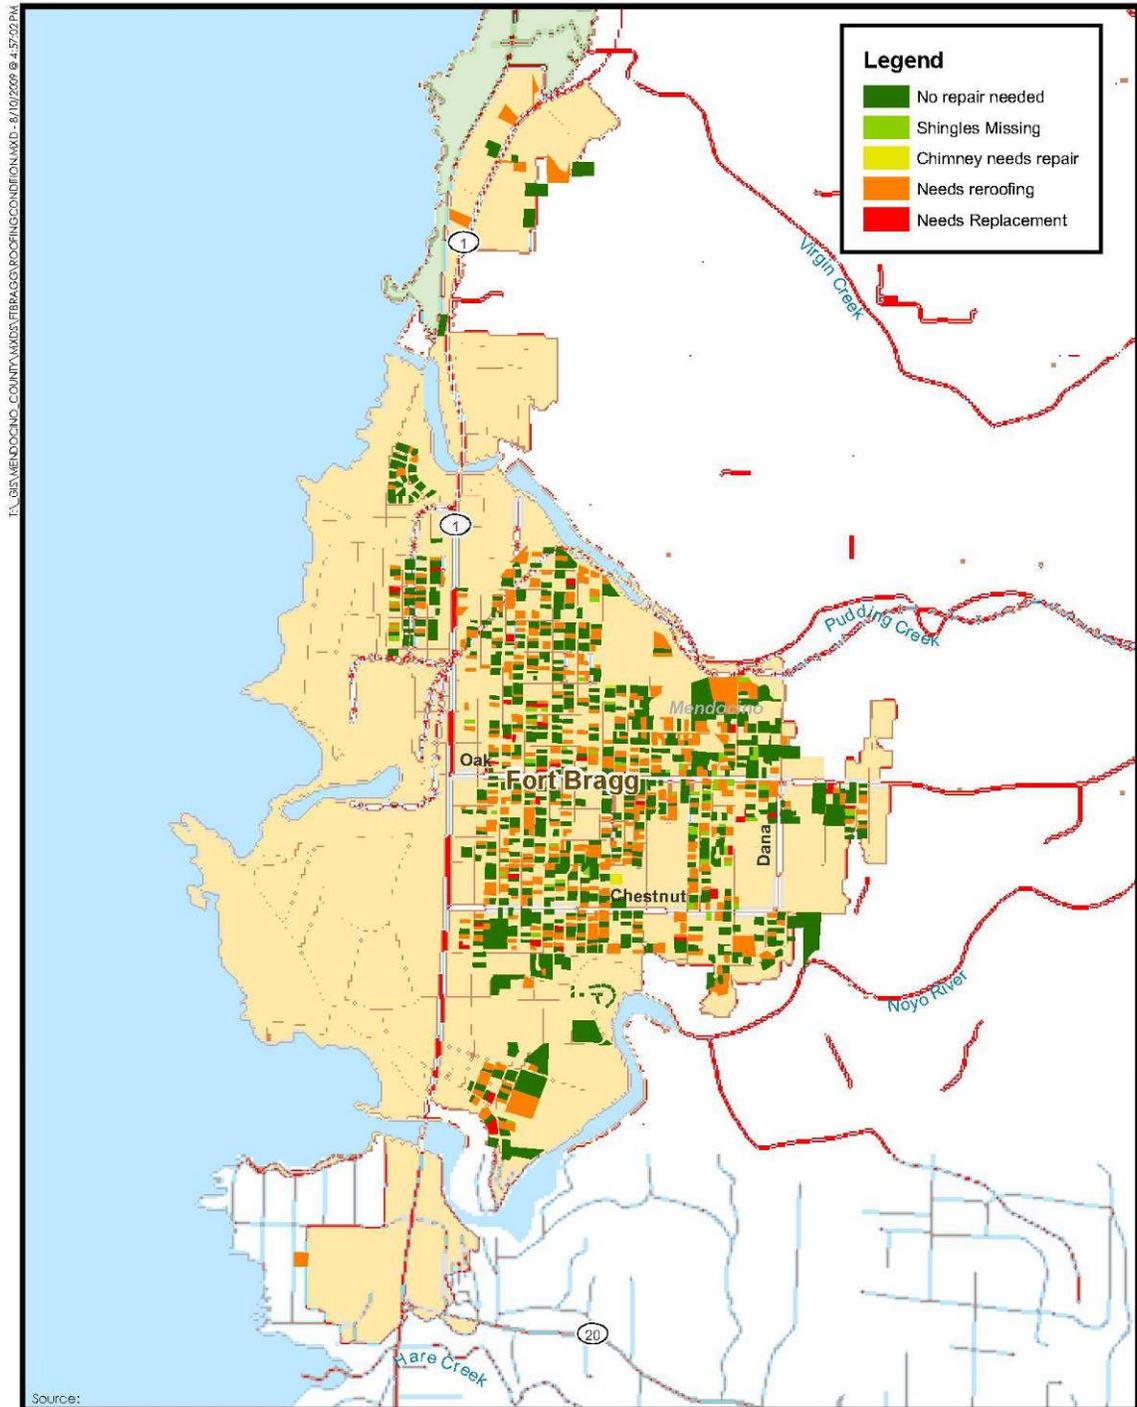
Figure 4 -- Roofing Conditions

Four out of every 10 homes in Fort Bragg requires some form of roofing repair. One third require re-roofing. Few (41) appear to require structural or other significant repair. Multi-family structures are in noticeably better roofing repair than other structures. Duplexes are in the worst overall condition with over half requiring repair, although none severe. Mobilehome roofs were generally not able to be observed or were not of such a type as to be considered “roofing.” (Please see Table 6.)

Structures requiring roofing repair were not concentrated in any particular geographic area nor was the severity of repair need higher in any particular section of the City. (Please see Figure 4.)

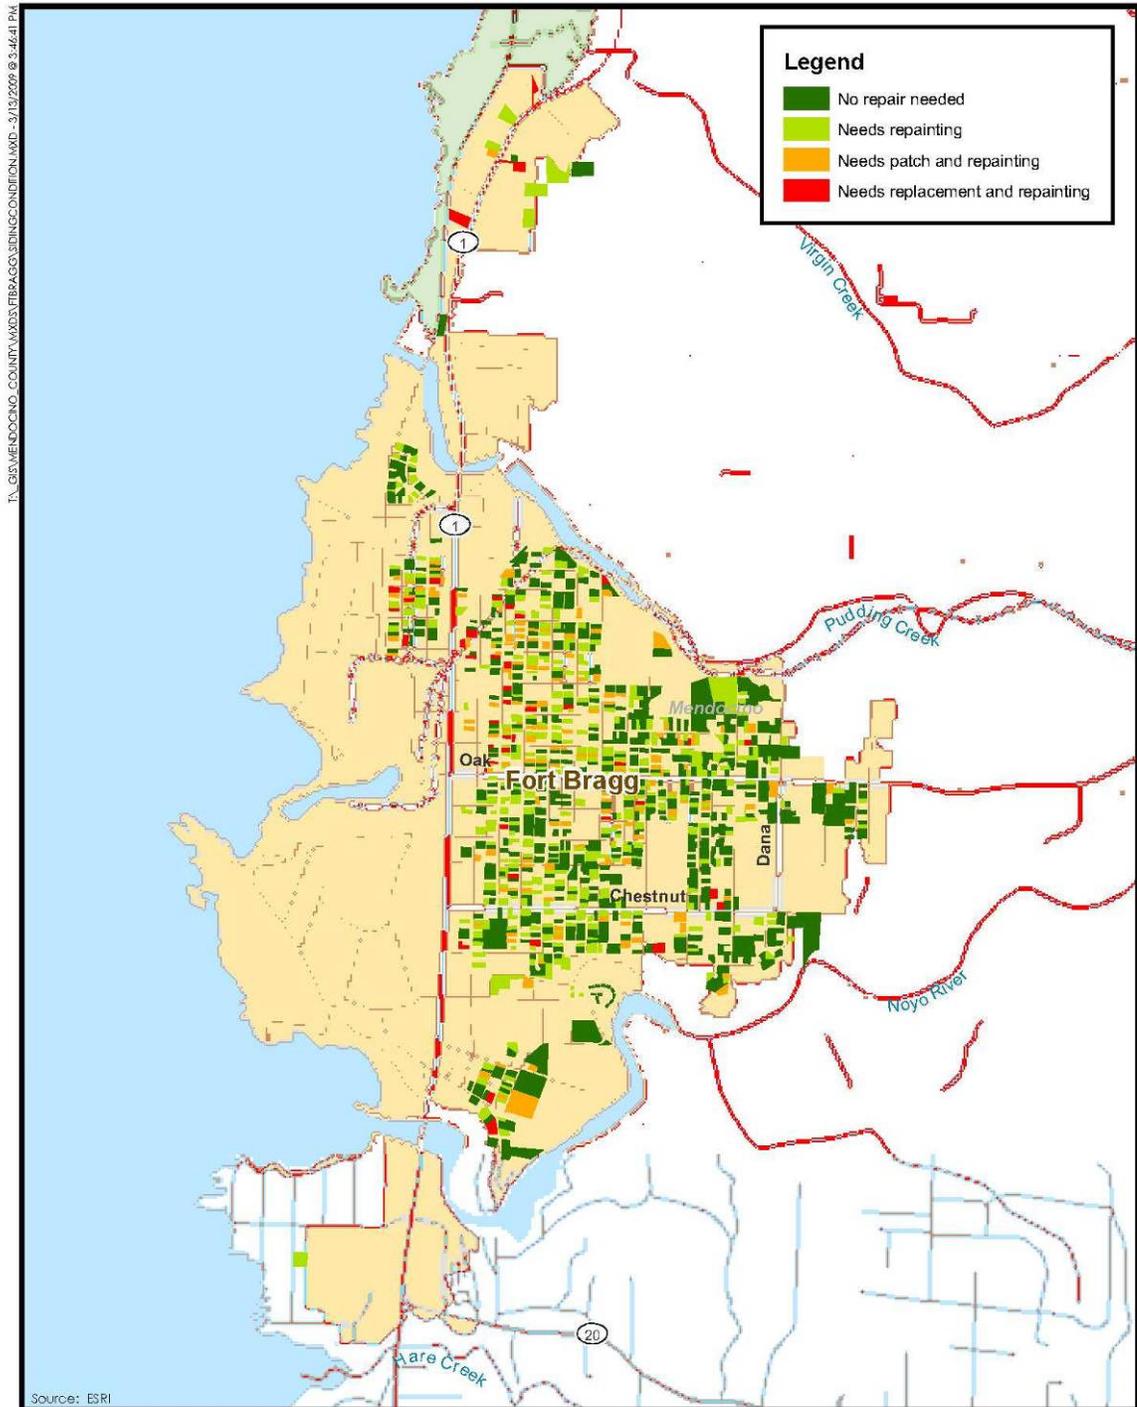
Figure 5 -- Siding Conditions

The siding of most housing in Fort Bragg is in good condition (84%). One third of the structures surveyed only require painting. Of the 243 structures that require siding repair, 25% require significant repair or replacement. Single-family attached homes are in particularly good shape as are multi-family structures. Single-family homes with detached garages and second dwelling units have the greatest need for siding repair. (Please see Table 7.)

Structures requiring siding repair were not significantly concentrated in any particular geographic area nor was the severity of repair need significantly higher in any particular section of the City. There appears to be a slightly higher incidence of repair and re-painting needed of siding along the western edge of town. This would be expected as these homes are more subject to the prevailing winds and ocean weather. (Please see Figure 5.)

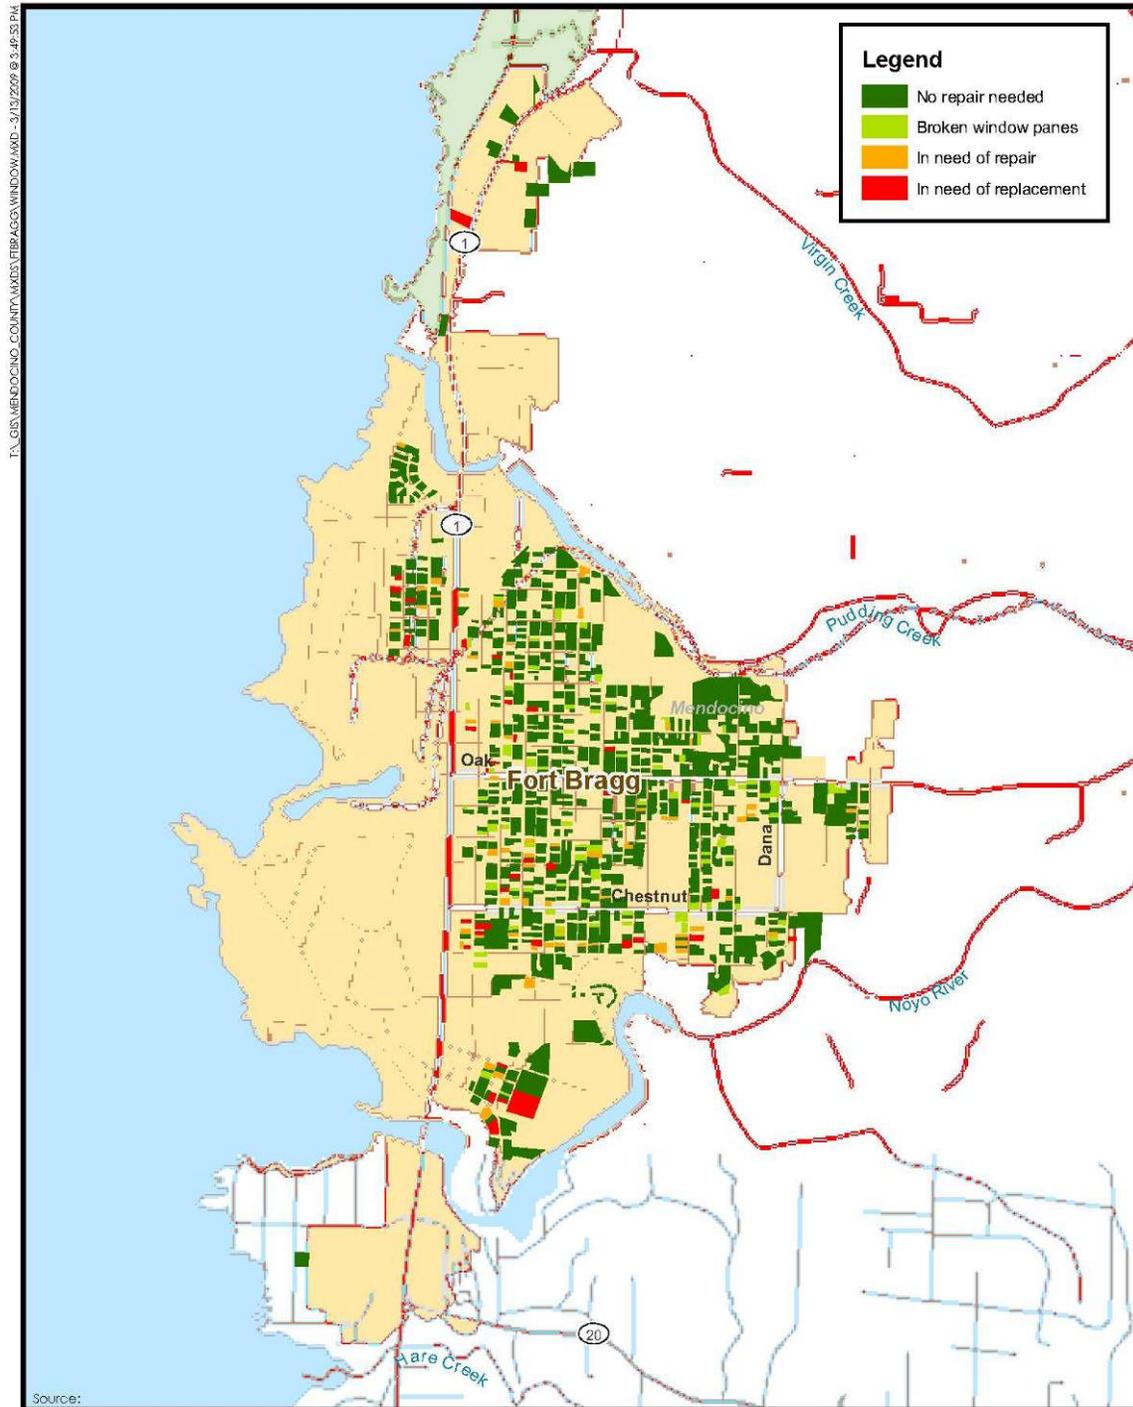
Figure 6 -- Window Conditions

Fewer than 1 in 10 of surveyed structures required significant repair or replacement of windows. Approximately 1 of every 15 structures surveyed (109 total) only required the repair of a broken window. (Please see Table 8.)

Structures requiring window repair were not significantly concentrated in any particular geographic area nor was the severity of repair need significantly higher in any particular section of the City. There appears to be a slightly higher incidence of window repair needed along the western and southern edges of town. This would be expected as these homes are more subject to the prevailing winds and ocean weather. (Please see Figure 6.)

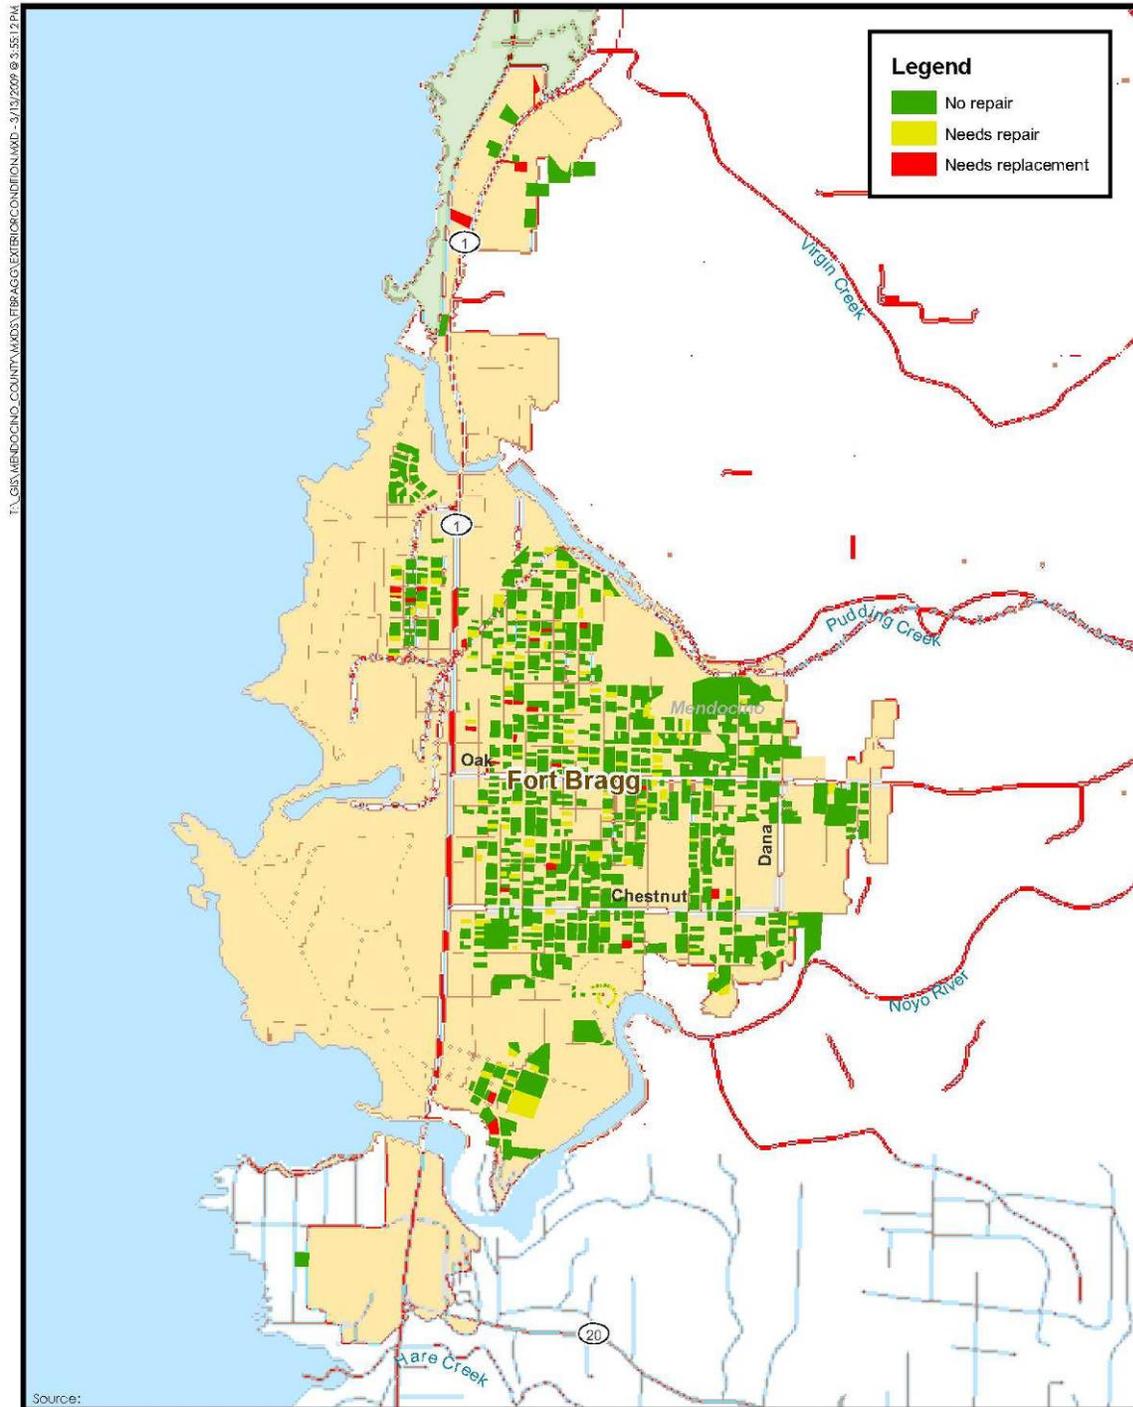
Figure 7 -- Exterior Structure Conditions

The exterior structures of homes in Fort Bragg (porches, staircases, railings) were found to be in generally good repair, 87% did not score any repair points in this aspect. In absolute terms, single-family homes appear to be in particularly good external repair and multi-family structures have the greatest repair needs. Those homes that require significant repair are limited to single-family homes with detached garages and second dwelling units. (Please see Table 10.)

Structures requiring the repair of exterior structures were not concentrated in any particular geographic area nor was the severity of repair need higher in any particular section of the City. (Please see Figure 7.)

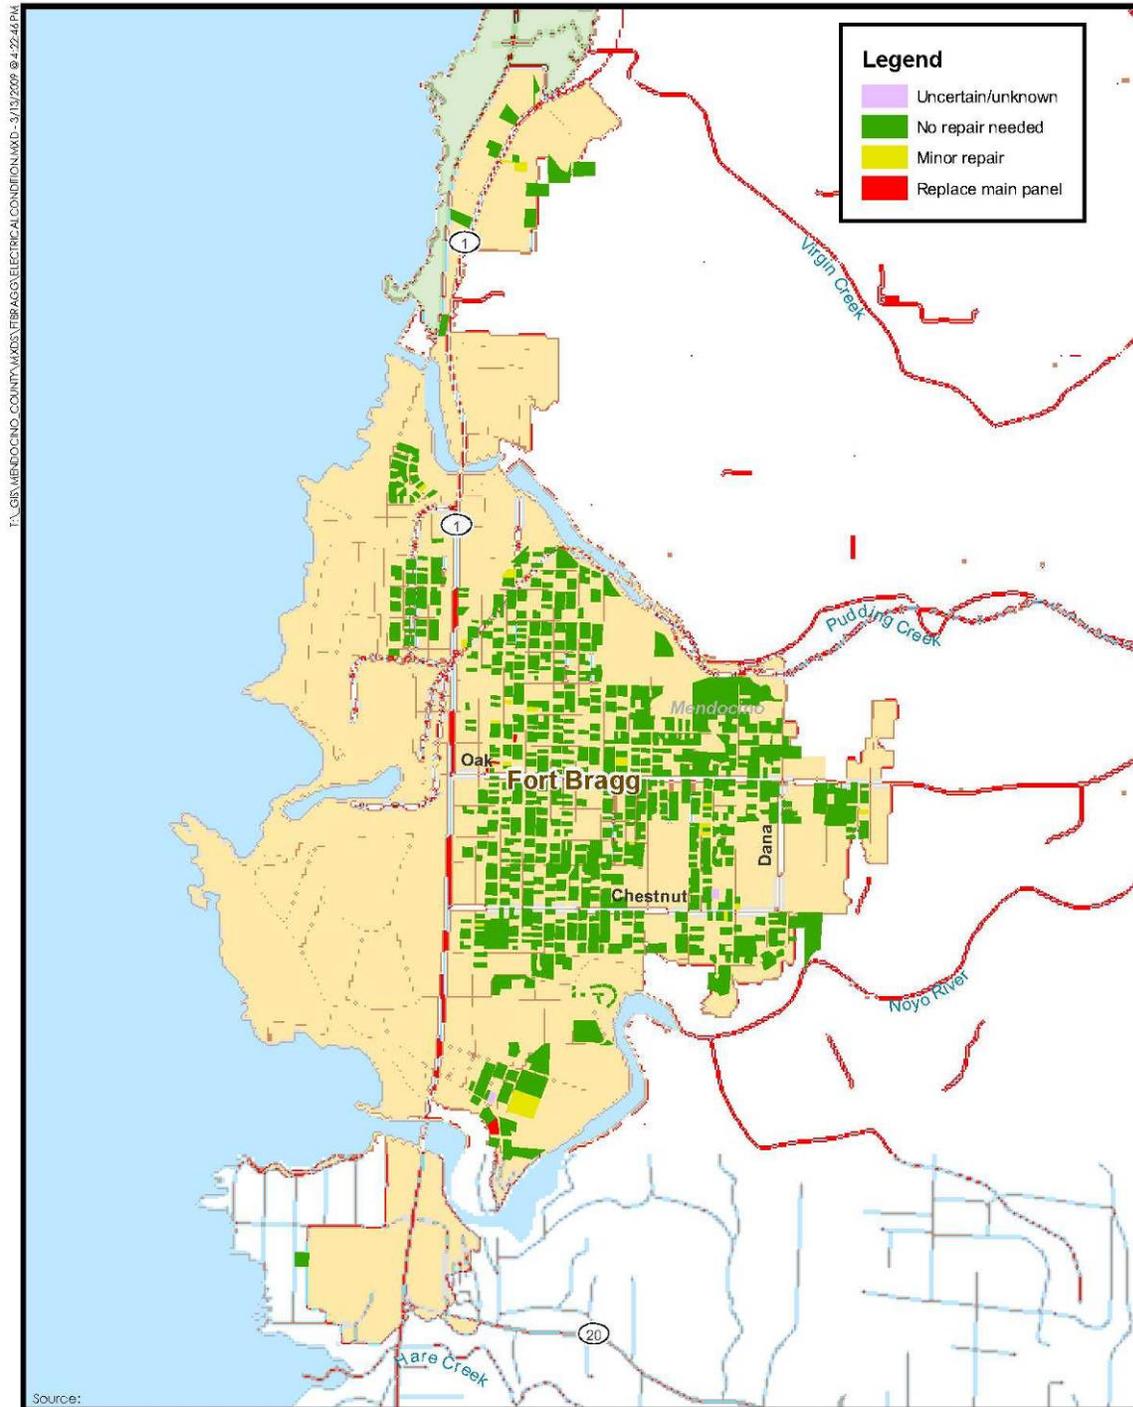
Figure 8 -- Electrical Conditions

The majority of structures surveyed did not require electrical repairs. Only 5 of the 33 structures that required any sort of electrical repair appeared to have serious repair needs. All but one were single-family homes with detached garages, the lone other was a second dwelling unit. (Please see Table 11.)

Structures requiring the repair of electrical systems were not concentrated in any particular geographic area nor was the severity of repair need higher in any particular section of the City. (Please see Figure 8.)
