CITY OF FORT BRAGG

MAIN STREET FIRE STATION SEISMIC EVALUATION

I.L. Welty & Associates
Fort Bragg, CA

June 29, 2009

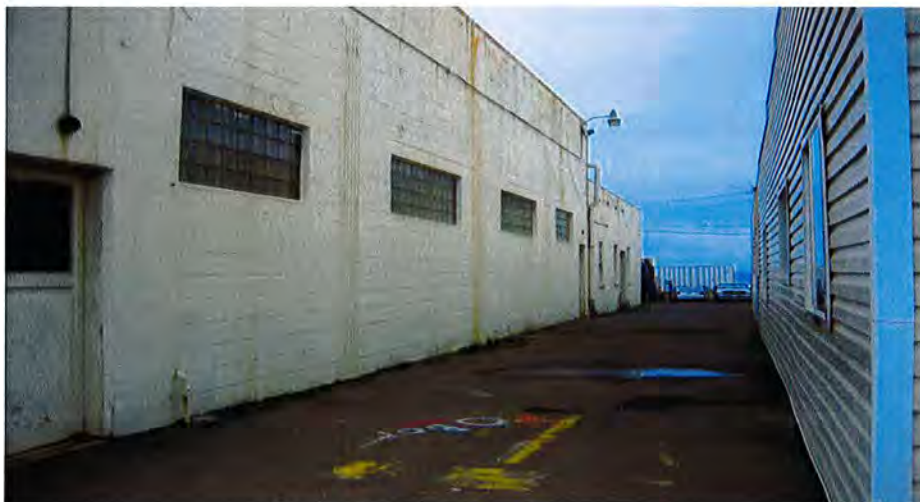
North Wall. Openings in Masonry Wall

There are many openings in the masonry walls, especially on the north side of the building. As a result, the capacity of the walls to resist lateral forces is limited by the length of the full height segments and the reinforcing detailing around the wall openings. Resistance to lateral forces in the direction parallel to the wall will be concentrated in the longer, stiffer segments and reinforcing along the length of the wall is required to transfer or “collect” the forces generated in one portion of the building to the stiffer segments. On the north wall line for example, the longest wall segment is near the west end of the rear area. Based on its length, this segment should resist approximately half the lateral force on the line. However, collector reinforcing would have to be provided to account for the change in roof height between the building segments. If the collector element is lacking, the force in the narrow segments will be larger and may exceed the capacity of the wall.

These openings also affect the performance of the building when subjected to lateral loads out-of-plane. Resistance to seismic loads in the direction perpendicular to the walls is a special concern in RM1 buildings. Large inertial forces due to the mass of the masonry walls must be resisted by the walls in bending between supports at the roof and the foundation. We determined that a minimal amount of vertical wall reinforcing is needed to satisfy the out-of-plane load requirements specified in ASCE 31. The amount of reinforcing provided is more critical in walls with openings because resistance to out-of-plane forces are concentrated in the full height segments. More vertical reinforcing is required each side of openings to provide the necessary bending strength in the full height segments. Additional horizontal reinforcing is also required above and below the opening in the wall to provide the strength for these segments to span between the full height segments. Lacking original construction documents and given the age of the building, a program of nondestructive testing would be required to determine the amount and distribution of vertical and horizontal reinforcing that is in the walls. We did not perform this testing because both the 1977 and 1997 project drawings indicate the city plans to demolish the North Wing and replace it with a new structure in the future. We mention the need for testing because it should be considered in any plan to rehabilitate the North Wing.

3. Strengthen the exterior walls and the interior wall between the North Apparatus Room and the rear area for out-of-plane seismic forces. Add vertical structural steel “strong backs” between the foundation and roof each side of window openings.¹ This repair addresses deficiency 5.
4. Strengthen the exterior and interior CMU shear walls for in-plane seismic forces (one of the methods below).¹ This repair addresses deficiency 5.
 - a. Add steel braced frames and new foundations on the interior.
 - b. Add reinforced concrete shear walls and new foundations on the interior.
5. Improve shear transfer from the CMU walls to the foundation.¹ Add structural steel angles at the base of the wall with epoxy set anchors in the wall and foundation. This repair addresses deficiency 5.

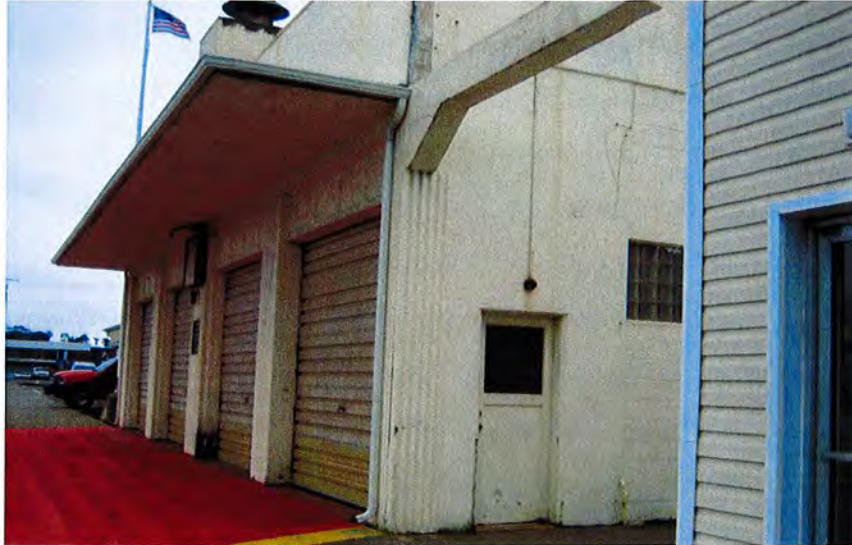
Concrete Frame and Tie Beam on East Wall

2. Non-ductile concrete moment frame at east (front) elevation. Most of the non-compliant checklist statements are reinforcing detailing requirements such as transverse tie spacing, bar hooks and bar splices that were not requirements at the time of construction. Historically, failures of reinforced concrete columns without closely spaced transverse reinforcing ties have occurred when the column deforms in an earthquake. Furthermore, the original design may have relied on the masonry walls of the building to the north for the lateral system and the concrete frame may have been designed for gravity loads only.

2. Strengthen the in-plane shear capacity of the east wall (one of the methods below). This repair addresses deficiency 2.
 - a.
 - i.) Add a steel braced frame in a frame bay.

- ii.) Fill in a frame bay with a reinforced concrete shear wall.
 - iii.) Add a steel moment resisting frame to back the concrete frame.
 - iv.) Add a fiber reinforced polymer (FRP) overlay on the concrete frame.

- b. Strengthen the foundation to resist shear and overturning forces.¹
 - c. Remove concrete beam between the North Apparatus Room and the

adjacent building to the north.

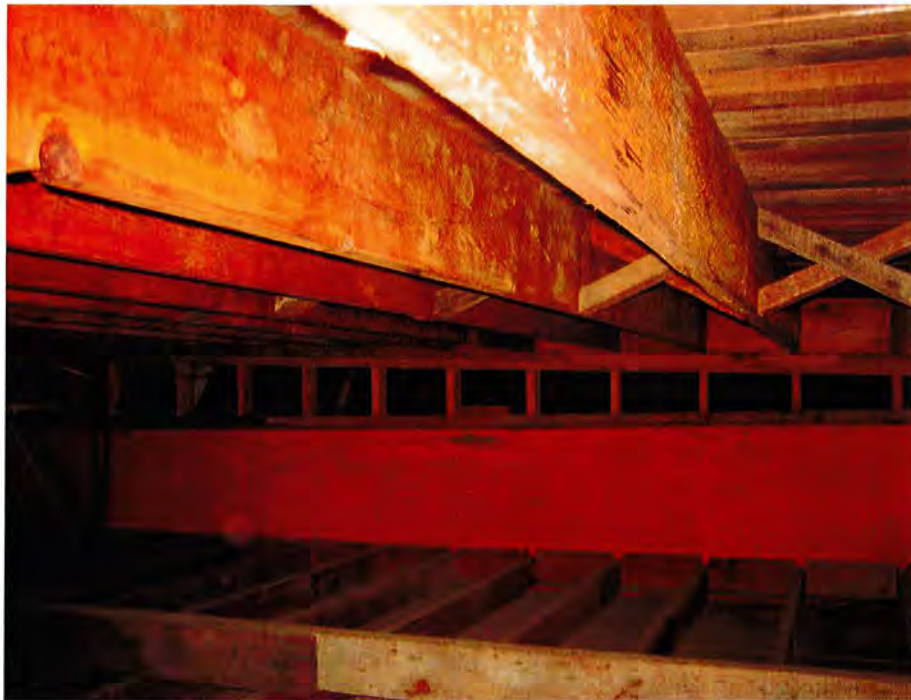
Roof Framing in North Apparatus Room

We could not determine if plywood sheathing was installed over the lumber sheathing as shown in the 1972 roof modification drawing. The rear area roof diaphragm is supported by field-built wood trusses that span in the east-west direction.

3. Inadequate shear strength in the roof diaphragm. The straight sheathed diaphragm does not have adequate capacity for the demands in either direction for both the North Apparatus Room and the rear area. The plywood overlay on the North Apparatus Room, if installed, does not have adequate capacity for the demands in either direction.

1. Brace the tops of the CMU walls and concrete frame for out-of-plane loads and strengthen the roof diaphragm of the North Apparatus Room and the rear area (no alternative). These repairs address deficiencies 1, 3 and 4. Work scope items are

- a. Add ties between the walls and roof around the perimeter of both the North Apparatus Room and the rear area.
 - b. Add continuous cross ties in the east-west direction of the North Apparatus Room.

- c. Add continuous cross ties in the north-south and east-west direction of the rear area.
 - d. Remove the existing roof sheathing and replace with new structural wood panel (plywood or oriented strand board) sheathing.

- e. Add blocking and special nailing at boundaries of diaphragms and subdiaphragms.
 - f. Add in-plane shear transfer connections between the walls and roof.

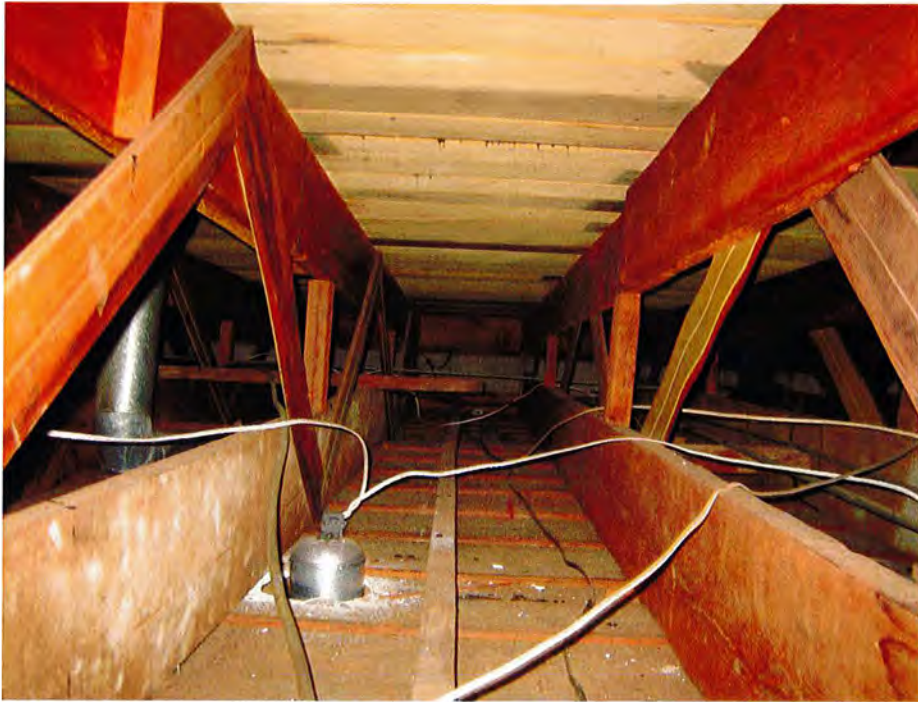
Roof Trusses in Rear Area

There were very few connections between the roof framing and wall in both portions of the building.

This lack of connection is a reason RM1 type buildings have performed poorly in past earthquakes. Connections between the walls and roof transfer the out-of-plane lateral forces into the roof diaphragm and the diaphragm distributes these forces to the vertical lateral force resisting elements. It is also necessary to have continuous cross ties (interconnected framing members in the roof) to keep the walls from separating from the roof. The steel beams in the Apparatus Room are the only continuous roof elements.

1. Inadequate out-of-plane ties between CMU walls and concrete frame and the roof. There is no positive connection between the walls and the roof diaphragm in the east-west direction (verified by observation). Steel girders connected to concrete column on the north and south walls of the North Apparatus Room provide a means of transferring load to the roof diaphragm. However, the framing on top of the steel beams is unsheathed and connections to the steel beam were not apparent. Ledger connections to the walls were not apparent. No other wall ties were observed. Cross ties are present in the north-south direction of the North Apparatus Room (steel girders approximately 14 feet on center). There are none in the east-west direction and there are no connections of roof framing to walls to transfer wall out-of-plane forces to the roof diaphragm. There are no cross ties in the rear area.

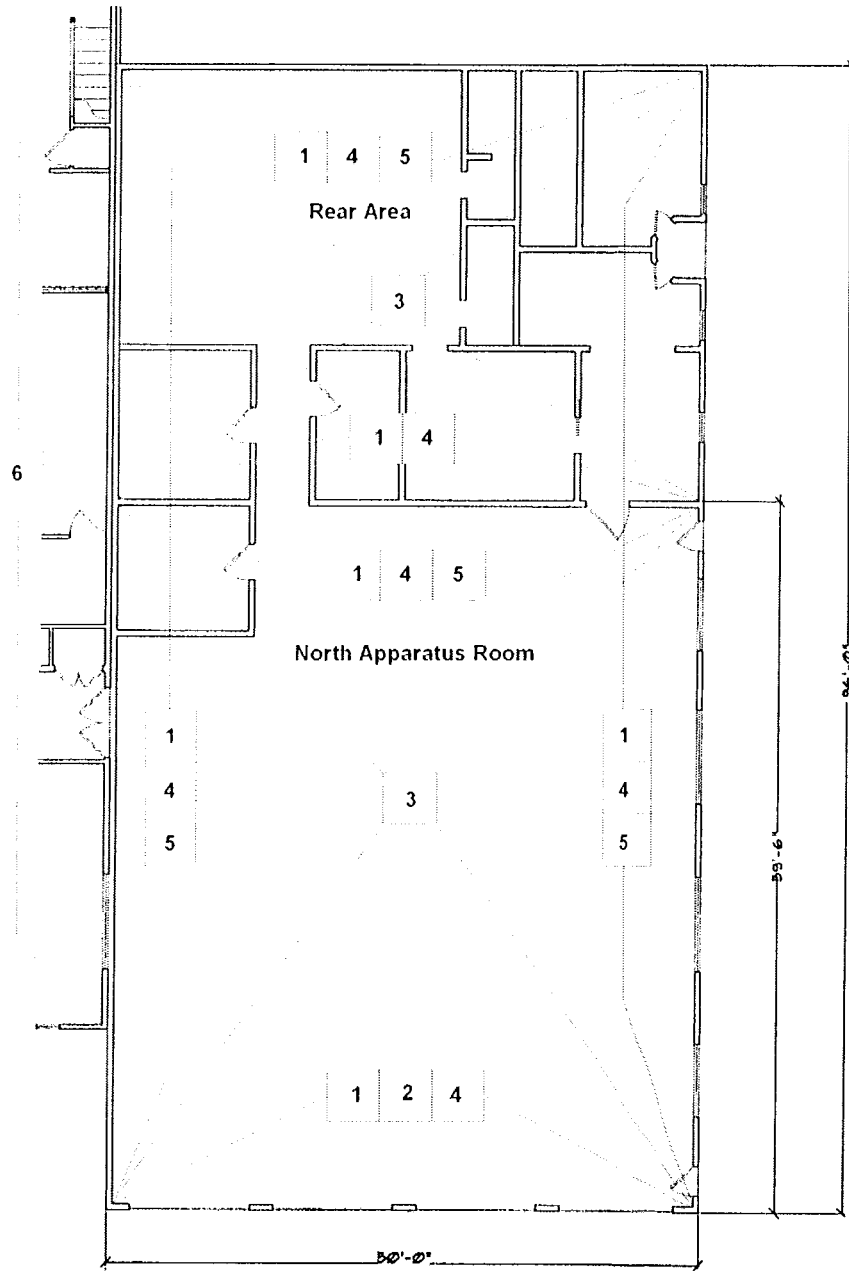
North Wing Potential Deficiencies

4. Inadequate in-plane shear transfer capacity between the roof diaphragm and CMU walls and concrete moment frame. Few connections between ledgers or edge members and shear walls were observed. Connections between the roof diaphragm boundary members and shear walls were not observed.

5. Inadequate in-plane shear capacity in CMU walls. The non-compliant statements from the Tier 1 checklists were based on the assumption that the walls were likely to have minimal reinforcing and the walls have large openings. The wall reinforcing may also be inadequate to resist out-of-plane loads in bending.
6. No seismic separation with adjacent construction. The 1977 plan drawings show no gap between the north wall of the Offices and Crew's Rooms building and the concrete columns on the south wall of the North Apparatus Room. Drawings of 1997 addition show the new wood framing built up against the CMU walls. This condition was confirmed by observation.

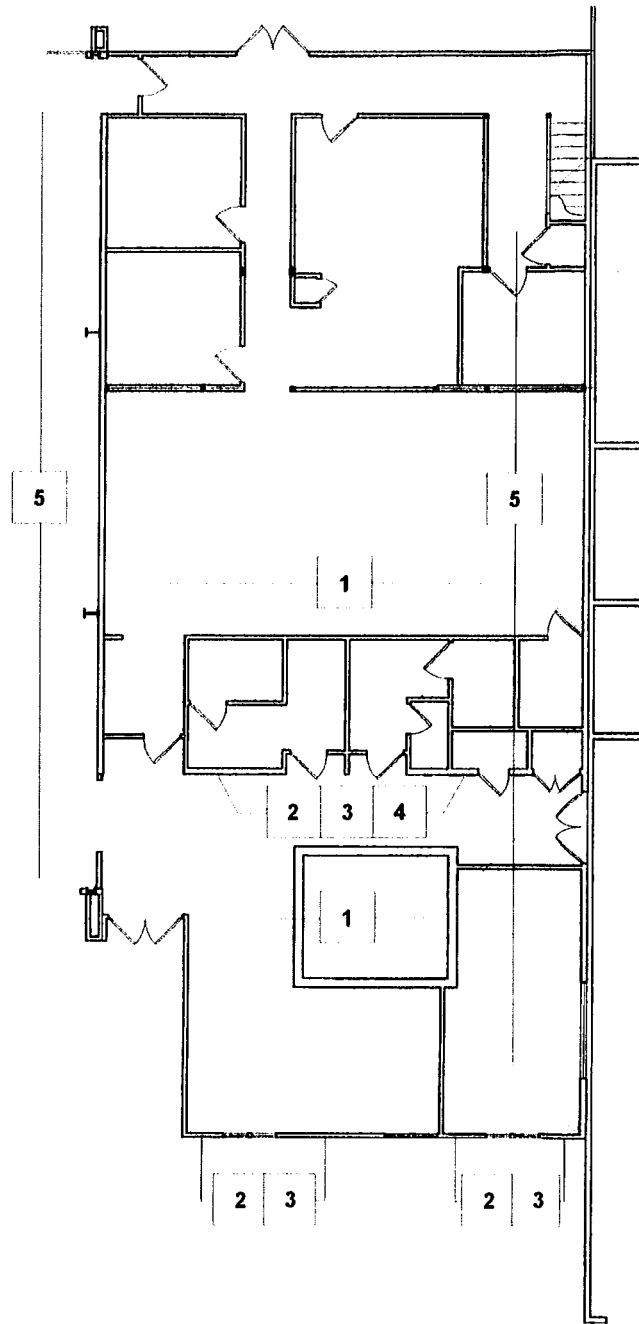
Offices and Crew's Rooms Potential Deficiencies

1. Both lines of north-south interior shear walls are not connected to the roof diaphragm. The 1977 construction drawings call for the interior shear wall on the through corridor to be extended to the roof. The wall does extend to the roof but the blocking between roof trusses is not connected to the wall. The 1997 construction added another wall to the west, we assume to compensate for removing some of the existing wall on the through corridor. There was no detail showing this new wall's connection to the roof. The wall does not extend above the bottom of the trusses and there are no panels or infill between trusses to transfer forces from the roof to the top of the wall.

2. The 1977 construction likely lacks foundation hold-downs at the ends of shear walls. The foundation plan and details and the framing plans and sections do not show hold-downs at the ends of plywood sheathed shear walls. Based on our analysis, the shear walls at the front of the building and the interior shear walls on the west side of the north-south through corridor require hold-downs.

3. The 1977 construction likely lacks sufficient anchor bolts at shear walls. The 1977 and 1997 drawings show anchor bolts in walls at 4 feet on center. Based on our analysis, the shear walls at the front of the building and the interior shear walls on the north-south through corridor do not have the required anchor bolts to transfer the wall shear to the foundation.

4. The interior shear walls on the north-south through corridor do not have adequate shear capacity.
5. There are no seismic separations between this and the two adjacent buildings. The north wall of the Offices and Crew's Rooms are built against the south wall of the North Wing. The roof diaphragm of the one story portion abuts the south wall of the North Wing. The buildings will move laterally in an earthquake and may impact each other and create additional loads in the structure and possible damage. The south wall is common to both the Offices and Crew's Rooms and the South Wing and poses a similar problem.

1. Connect the two north-south interior shear walls to the roof diaphragm. These repairs address deficiency 1. Work scope items are
 - a. Add plywood sheathed blocking panels between existing roof trusses above the east wall of the Meeting Room/Day Room. Nail the roof sheathing to the top of the blocking panels.

- b. Connect the walls to the existing blocking on the west side of the north-south through corridor. Nail the roof sheathing to the blocking.
2. Add hold-downs on the ends of four shear walls on the east exterior wall and two shear walls on the west side of the north-south through corridor. These repairs address deficiency 2.

3. Add epoxy anchors in the sill plates of four shear walls on the east exterior wall and two shear walls on the west side of the north-south through corridor. These repairs address deficiency 3.

4. Add edge nailing to the two shear walls on the west side of the north-south through corridor. This repair addresses deficiency 4.
5. Provide seismic separations from the adjacent buildings at the roof level (1 story portion) and the second floor level (2 story portion).

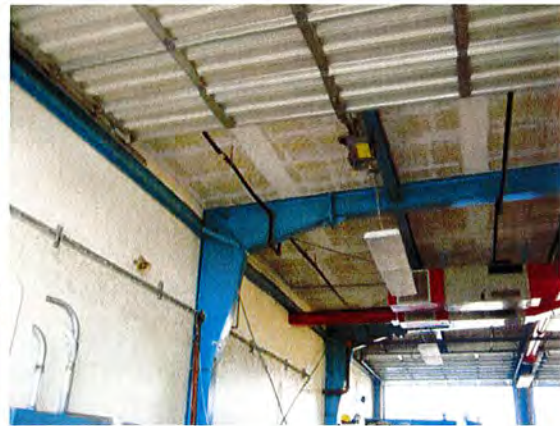
South Wing Interior Frames

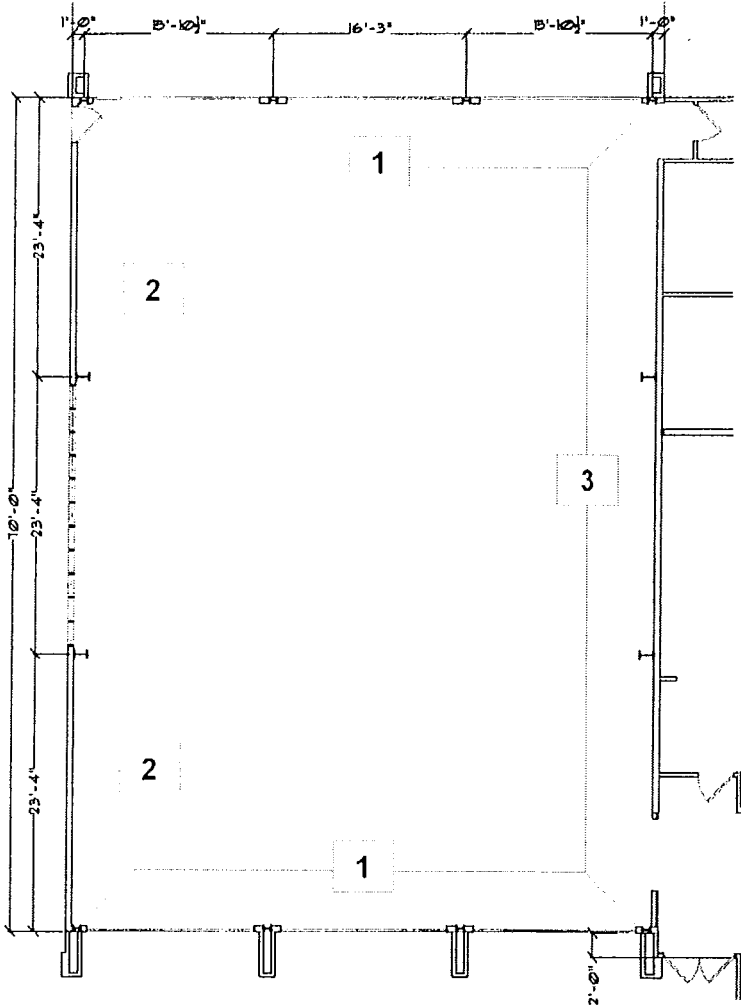
South Wing Potential Deficiencies

1. The steel gravity frames on the east and west elevations may permanently deform and block egress from the building.
2. The plywood sheathed wall segments on the south side require hold-downs at the ends.
3. There is no seismic separation between the South Wing and the Offices and Crew's Rooms building.

1. Weld cover plates on the east and west steel frame columns to create box sections. Separate the wood framing from the columns and reframe the wood sheathed enclosure around the column and make the support for the roll up doors independent from the steel frame. These repairs address deficiency 1.
2. Add hold-downs on the ends of the two shear wall segments on the south wall. This repair addresses deficiency 2.
3. Provide a seismic separation at the north wall. These repairs along with the repair in the Offices and Crew's Rooms building address deficiency 3.
 - a. Block out the wood framed wall at the interior frame columns.
 - b. Add hold-down at the ends of the remaining shear wall segments.

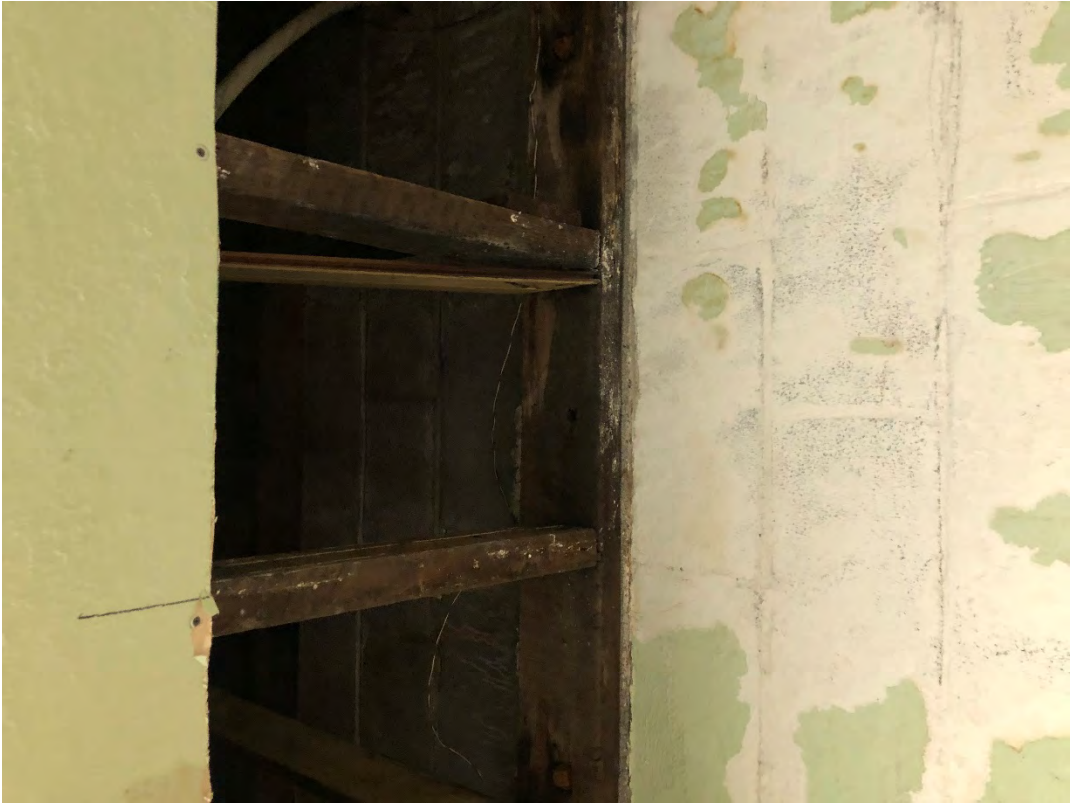
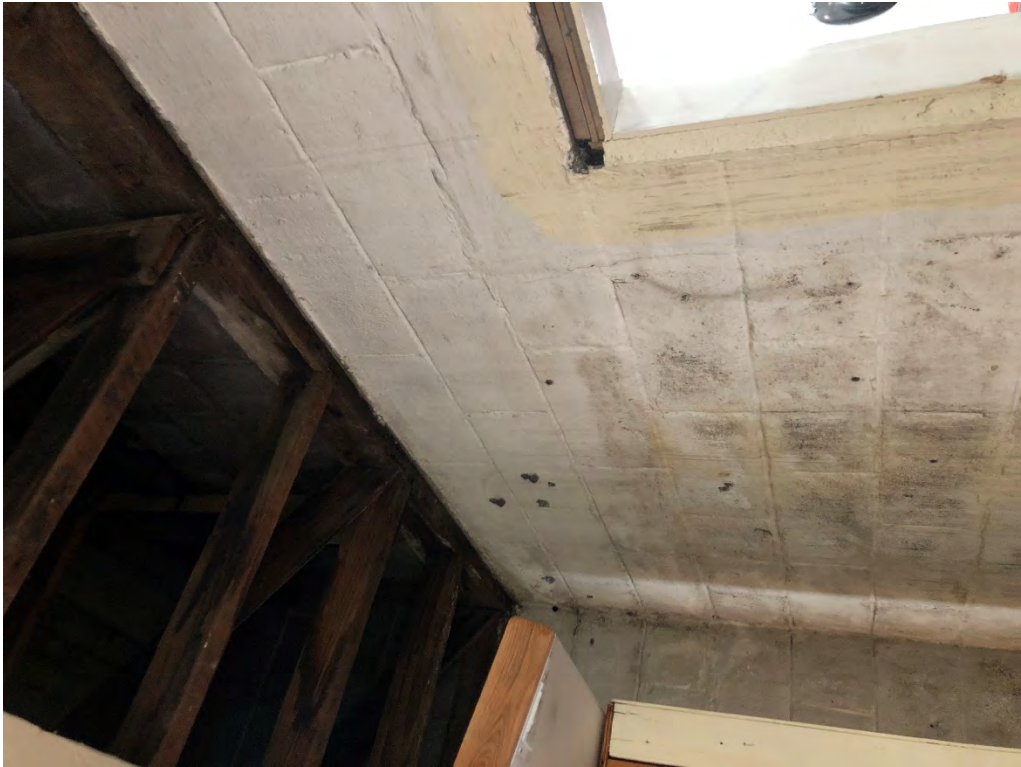
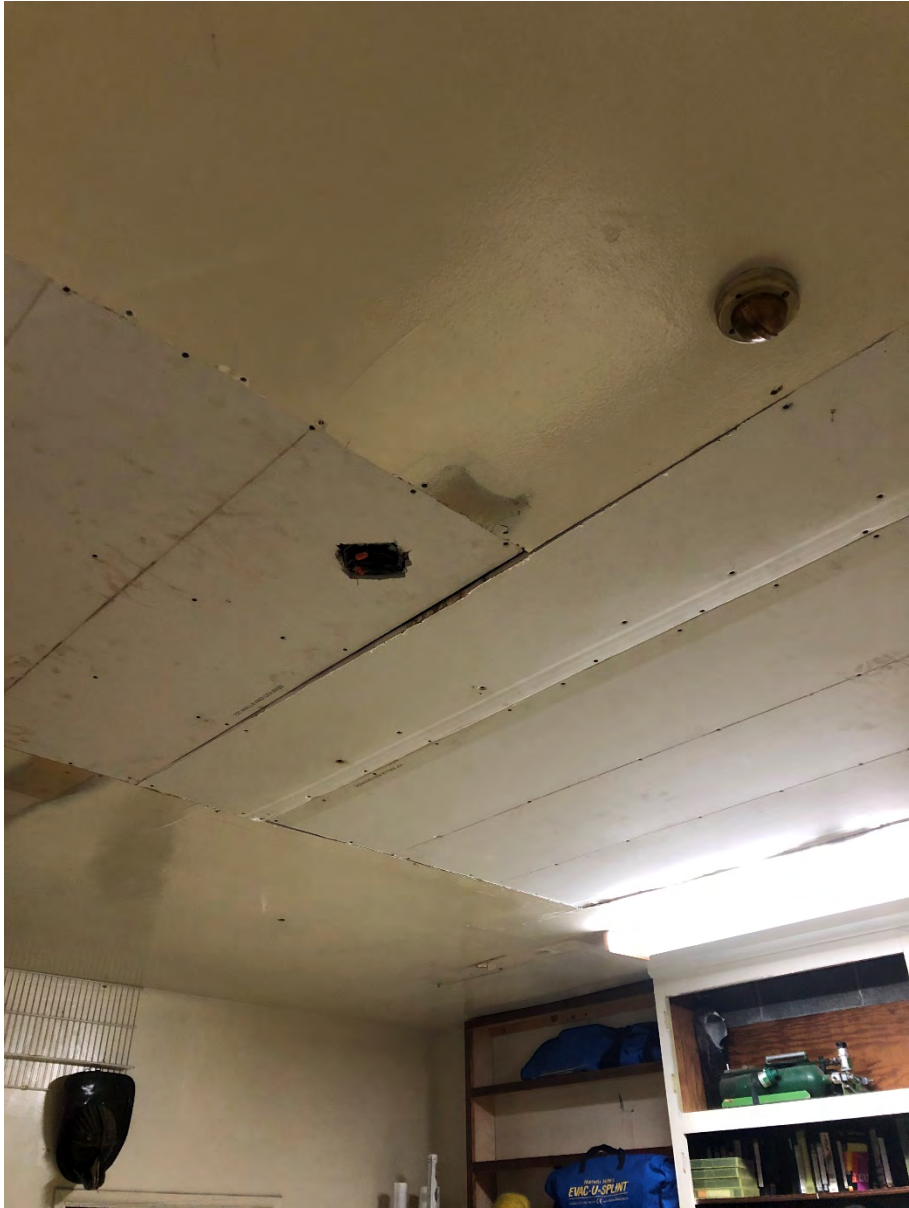
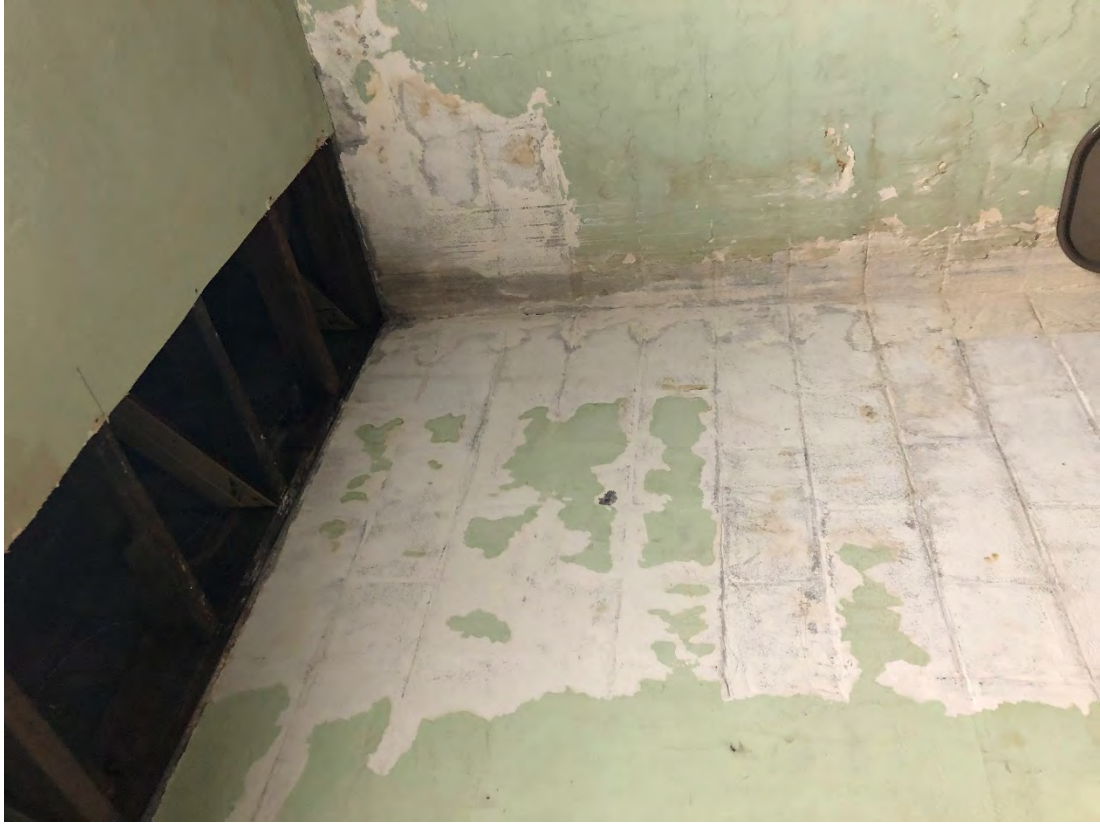
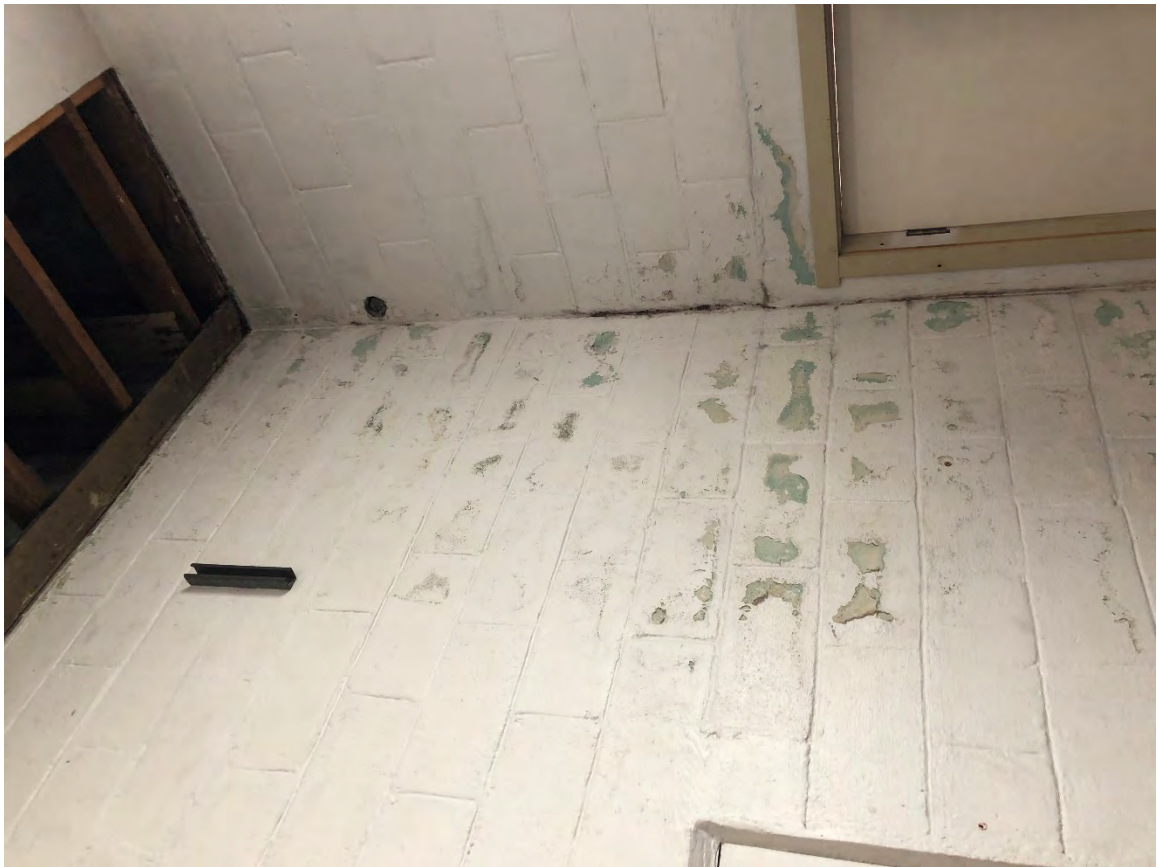
Fort Bragg Fire Station: Visual Deterioration/Damage from leaky roof
