CITY OF FORT BRAGG PUBLIC FACILITIES MASTER PLAN

Grossmann Design Group

March 6, 2007

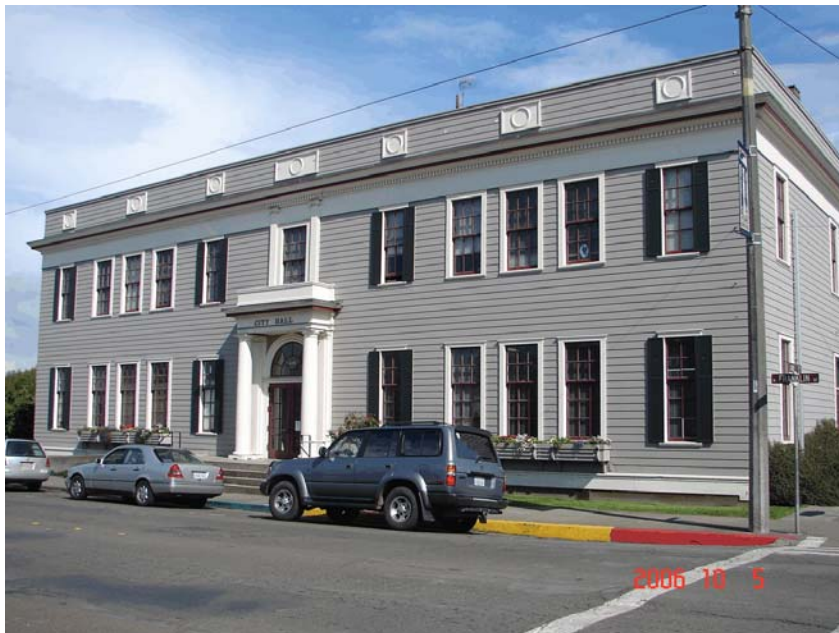
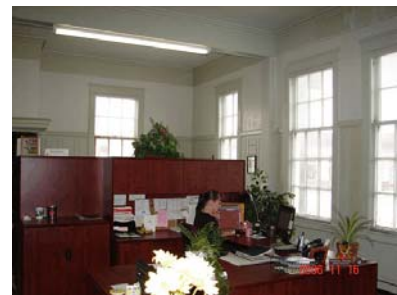
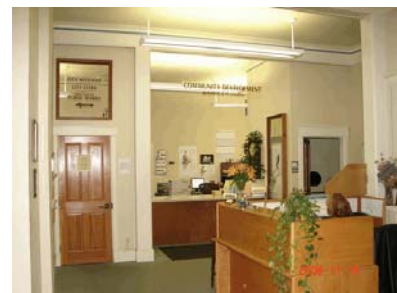
The City Hall is a two-story, wood framed building, regular in shape, with several interior walls and with exterior walls that are continuous to continuous concrete strip foundations. The Recreation Center is a part of the same building, located to the east of City Hall. The building was constructed in 1921 and is in generally good condition. The building is not an essential facility as defined by ASCE-31 "Seismic Evaluation of Existing Buildings". Based on our review, we consider there to be an appreciable risk of major structural damage to the City Hall in the event of a major earthquake, and that the building will

not meet the Life Safety criteria as defined by ASCE-31. In our professional opinion, there is an appreciable risk that the building will move off of its foundations, and/or rack below the first floor, such that repair is not economically justified. Seismic deficiencies include:

- ▶ Foundation cripple walls lack plywood shear panels.
- ▶ Foundation mud sills are not bolted to foundations.
- ▶ Brick masonry fireplace chimneys that extend above the roof appear to be unreinforced.
- ▶ The City Hall is not seismically separated from the Recreation Center.

The exterior siding is wood with wood windows. The wood siding is in good condition. The wood windows that provide natural ventilation are fair - good condition and require some repairs.

The existing roof is a built-up roofing system with a mineral surfaced cap sheet. Drainage is provided by down spouts. The roof is in fair condition and requires some maintenance repairs.

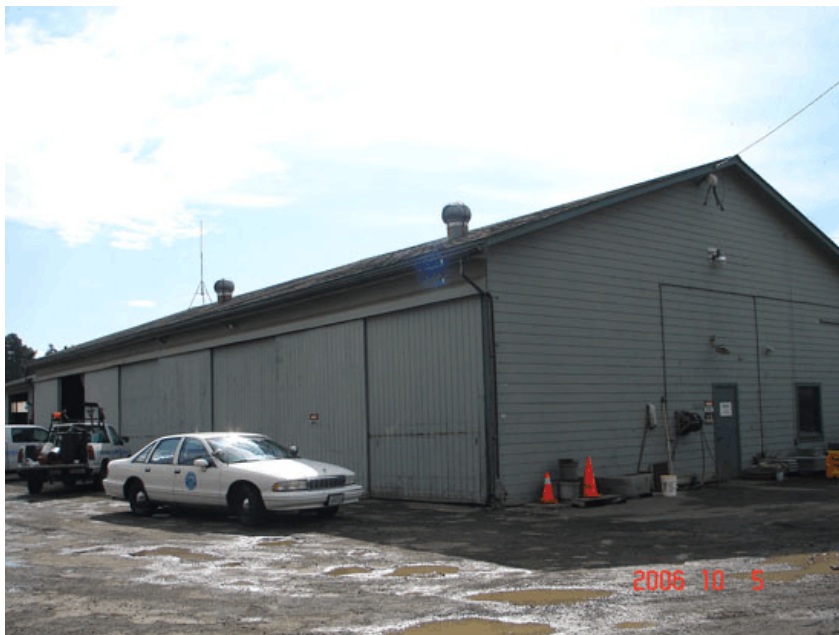
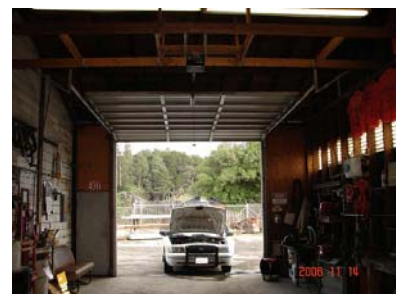
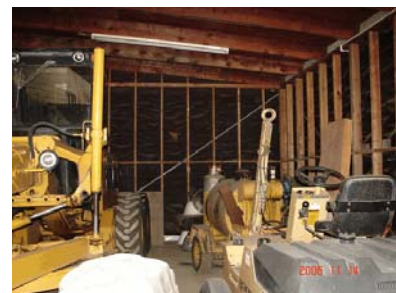
The cost of correcting the existing building deficiencies is not commensurate with the value of the building. Replacing the existing building with a new pre-engineered steel frame building with interior improvements as required by the users would serve the long term interests of the City of Fort Bragg rather than renovating the building. Renovations would require either strengthening or the replacement of the majority of the existing wood frame structure, and the addition of new architectural elements such as overhead garage doors and siding, and new mechanical and electrical systems. The actual salvageable building elements are minimal. A cost benefit analysis, although not a part of a facilities master plan, would probably substantiate replacement.

grader, a backhoe, trucks, and lifts owned by the City of Fort Bragg. Currently a grader, a backhoe, trucks, and lifts are not parked in a weatherproof enclosure which results in premature deterioration of their components. The Fort Bragg climate is considered a coastal climate, and the failure to protect vehicles and equipment from moisture as described in the SERVICE AREA AND DEMAND FOR SERVICES section customarily reduces the Useful Service Life of vehicles and equipment.

In addition, a new weatherproof parking structure with eight [8] oversized parking spaces for trucks and equipment is required; the current size of the corporation yard building is not large enough to park a

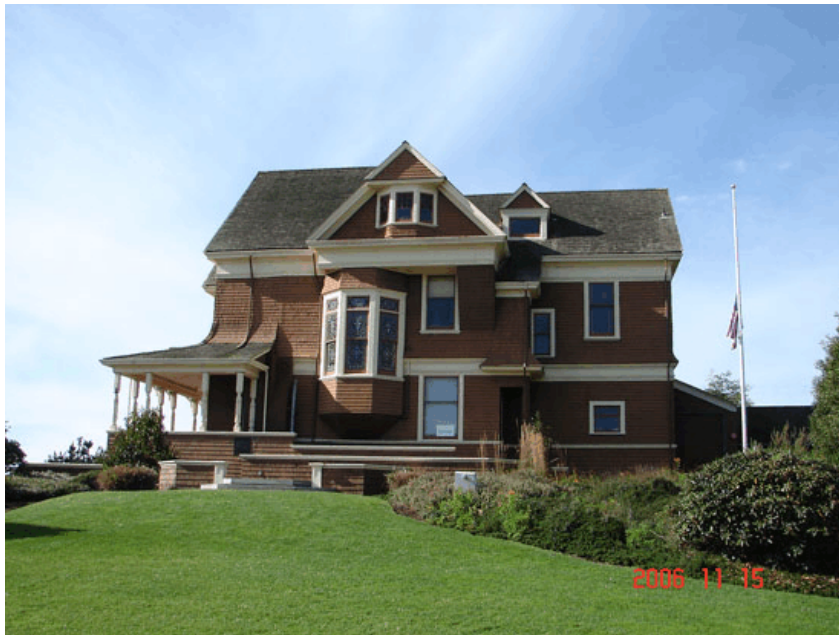
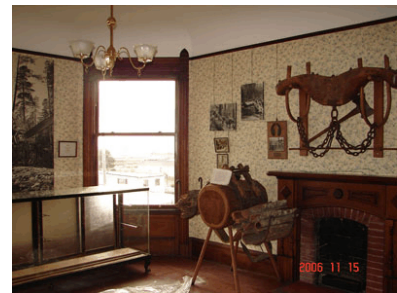
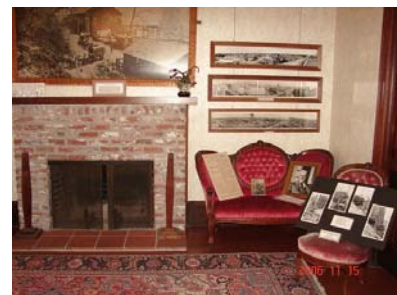
The building is not currently listed in the *National Register of Historic Places* nor is it listed as a California Landmark. It is probably eligible for listing in the *National Register of Historic Places* as the criteria for eligibility includes recognition that a property is of significance to the community. The building represents a historically significant type and period. It would be in the interest's of the City of Fort Bragg to have the Guest house listed in the *National Register of Historic Places* as the building would become eligible for grants from public agencies related to preservation, conservation, and rehabilitation.

If an historic building structures report has not been prepared it would be prudent to have a specialty consultant prepare one. The building exteriors need repair and rehabilitation. It is recommended that

all work be undertaken in accordance with *The Secretary of the Interior's Standards for the Treatment of Historic Properties with Guidelines for Preserving, Rehabilitating, Restoring and Reconstructing Historic Buildings*, and with State of California Office of Historic Preservation guidelines and standards for the preservation of historical resources including but not limited to the *2001 California Historical Building Code*. Primary emphasis should be placed on preservation.

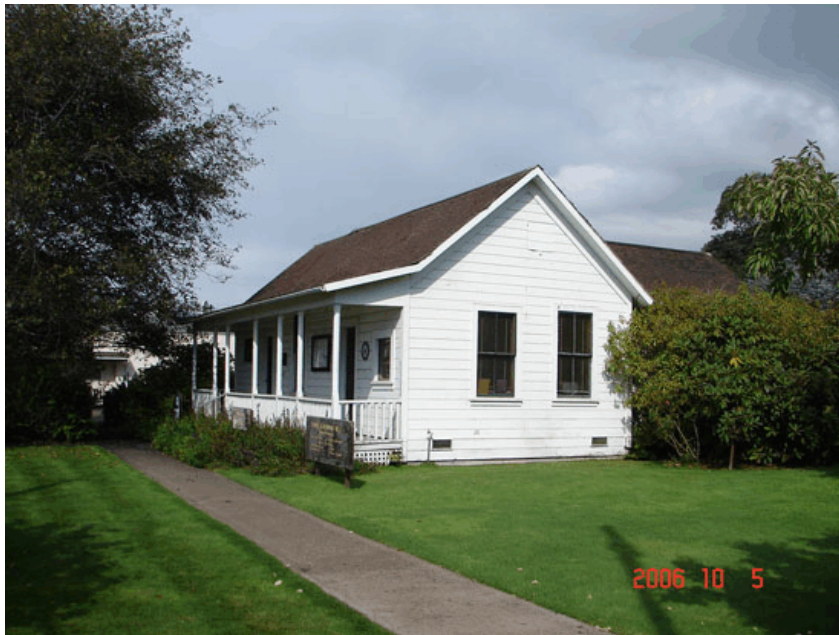
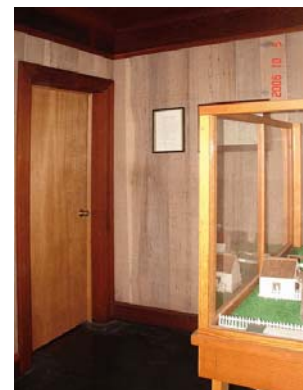
The building exteriors are wood and in poor condition. The building exteriors require immediate repair or replacement to protect the interiors from damage due to water intrusion. All work shall comply with the referenced standards.

The building interiors are in fair to good condition. The wood interior paneling should be preserved. It is assumed the intent is to restore the interiors. All work shall comply with the referenced standards.

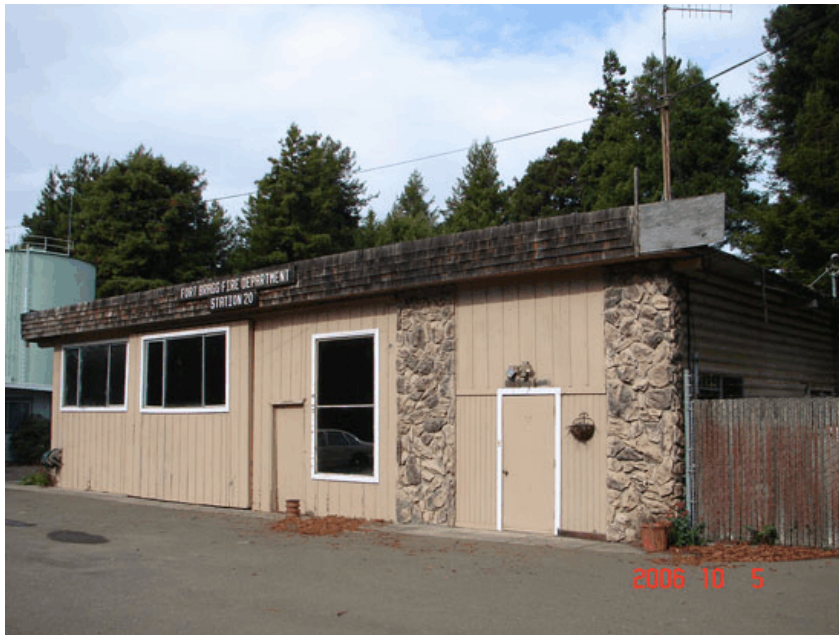
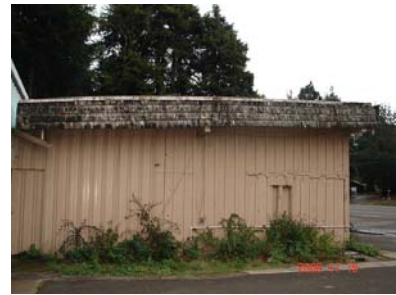
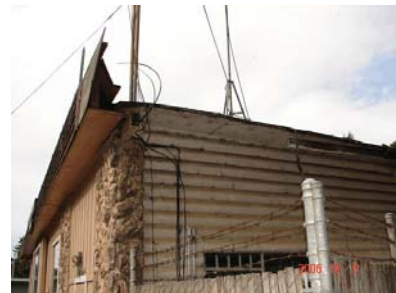
The Fire Station is a compilation of three buildings built in three different phases; the North Wing that houses the North Apparatus Room, the South Wing that houses the South Apparatus Room, and a central portion that includes Offices and Crews Rooms. It is an essential facility as defined by ASCE-31 "Seismic Evaluation of Existing Buildings". Construction is as follows:

Immediate Occupancy criteria as defined by ASCE-31 “Seismic Evaluation of Existing Buildings”. Both constructions meet the ASCE-31 “Seismic Evaluation of Existing Buildings” Benchmark Buildings criteria for Immediate Occupancy Performance Level, with the following exceptions:

- ▶ The 1977 construction likely lacks foundation hold-downs at the ends of shear walls.
- ▶ The 1977 construction likely lacks sufficient anchor bolts at shear walls.
- ▶ There are no seismic separations between either construction and the North and South Wings.
