CITY OF FORT BRAGG

MAIN STREET FIRE STATION SEISMIC EVALUATION

I.L. Welty & Associates
Fort Bragg, CA

June 29, 2009

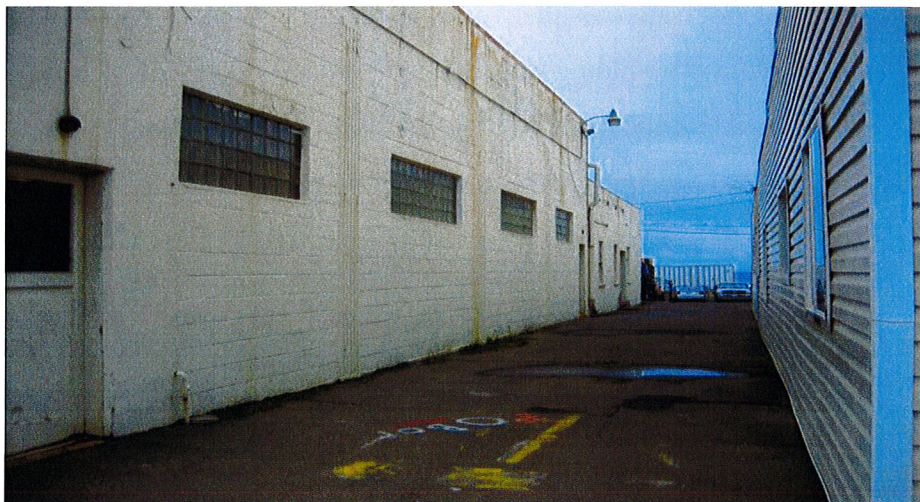
North Wall. Openings in Masonry Wall

There are many openings in the masonry walls, especially on the north side of the building. As a result, the capacity of the walls to resist lateral forces is limited by the length of the full height segments and the reinforcing detailing around the wall openings. Resistance to lateral forces in the direction parallel to the wall will be concentrated in the longer, stiffer segments and reinforcing along the length of the wall is required to transfer or “collect” the forces generated in one portion of the building to the stiffer segments. On the north wall line for example, the longest wall segment is near the west end of the rear area. Based on its length, this segment should resist approximately half the lateral force on the line. However, collector reinforcing would have to be provided to account for the change in roof height between the building segments. If the collector element is lacking, the force in the narrow segments will be larger and may exceed the capacity of the wall.

These openings also affect the performance of the building when subjected to lateral loads out-of-plane. Resistance to seismic loads in the direction perpendicular to the walls is a special concern in RM1 buildings. Large inertial forces due to the mass of the masonry walls must be resisted by the walls in bending between supports at the roof and the foundation. We determined that a minimal amount of vertical wall reinforcing is needed to satisfy the out-of-plane load requirements specified in ASCE 31. The amount of reinforcing provided is more critical in walls with openings because resistance to out-of-plane forces are concentrated in the full height segments. More vertical reinforcing is required each side of openings to provide the necessary bending strength in the full height segments. Additional horizontal reinforcing is also required above and below the opening in the wall to provide the strength for these segments to span between the full height segments. Lacking original construction documents and given the age of the building, a program of nondestructive testing would be required to determine the amount and distribution of vertical and horizontal reinforcing that is in the walls. We did not perform this testing because both the 1977 and 1997 project drawings indicate the city plans to demolish the North Wing and replace it with a new structure in the future. We mention the need for testing because it should be considered in any plan to rehabilitate the North Wing.

3. Strengthen the exterior walls and the interior wall between the North Apparatus Room and the rear area for out-of-plane seismic forces. Add vertical structural steel “strong backs” between the foundation and roof each side of window openings.¹ This repair addresses deficiency 5.
4. Strengthen the exterior and interior CMU shear walls for in-plane seismic forces (one of the methods below).¹ This repair addresses deficiency 5.
 - a. Add steel braced frames and new foundations on the interior.
 - b. Add reinforced concrete shear walls and new foundations on the interior.
5. Improve shear transfer from the CMU walls to the foundation.¹ Add structural steel angles at the base of the wall with epoxy set anchors in the wall and foundation. This repair addresses deficiency 5.

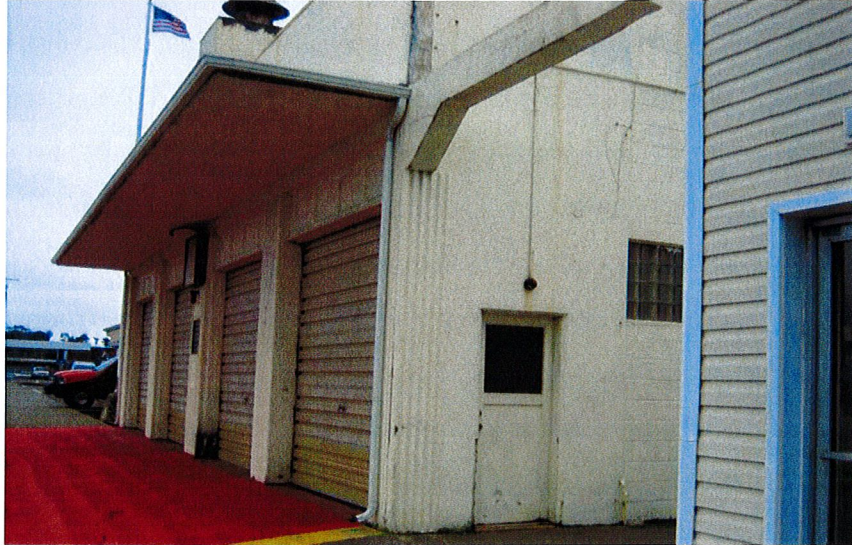
The east wall is a reinforced concrete frame. This frame is tied to the front wall of the building to the north (the former police station) by a concrete beam near the roof level.

Concrete Frame and Tie Beam on East Wall

2. Non-ductile concrete moment frame at east (front) elevation. Most of the non-compliant checklist statements are reinforcing detailing requirements such as transverse tie spacing, bar hooks and bar splices that were not requirements at the time of construction. Historically, failures of reinforced concrete columns without closely spaced transverse reinforcing ties have occurred when the column deforms in an earthquake. Furthermore, the original design may have relied on the masonry walls of the building to the north for the lateral system and the concrete frame may have been designed for gravity loads only.

2. Strengthen the in-plane shear capacity of the east wall (one of the methods below). This repair addresses deficiency 2.
 - a.
 - i.) Add a steel braced frame in a frame bay.

- ii.) Fill in a frame bay with a reinforced concrete shear wall.
 - iii.) Add a steel moment resisting frame to back the concrete frame.
 - iv.) Add a fiber reinforced polymer (FRP) overlay on the concrete frame.

- b. Strengthen the foundation to resist shear and overturning forces.¹
 - c. Remove concrete beam between the North Apparatus Room and the

adjacent building to the north.

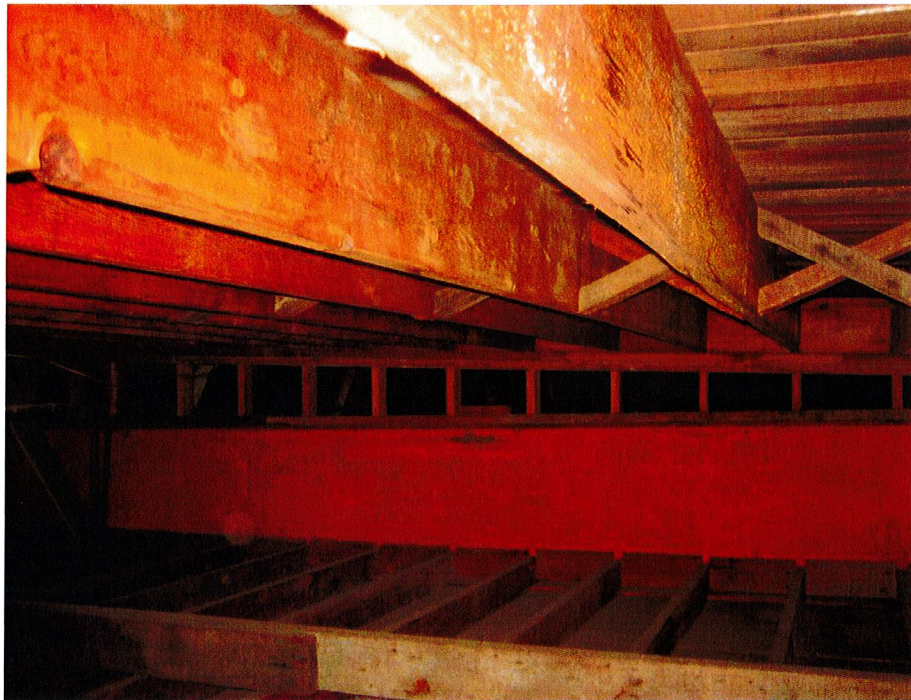
Roof Framing in North Apparatus Room

We could not determine if plywood sheathing was installed over the lumber sheathing as shown in the 1972 roof modification drawing. The rear area roof diaphragm is supported by field-built wood trusses that span in the east-west direction.

3. Inadequate shear strength in the roof diaphragm. The straight sheathed diaphragm does not have adequate capacity for the demands in either direction for both the North Apparatus Room and the rear area. The plywood overlay on the North Apparatus Room, if installed, does not have adequate capacity for the demands in either direction.

1. Brace the tops of the CMU walls and concrete frame for out-of-plane loads and strengthen the roof diaphragm of the North Apparatus Room and the rear area (no alternative). These repairs address deficiencies 1, 3 and 4. Work scope items are

- a. Add ties between the walls and roof around the perimeter of both the North Apparatus Room and the rear area.
 - b. Add continuous cross ties in the east-west direction of the North Apparatus Room.

- c. Add continuous cross ties in the north-south and east-west direction of the rear area.
 - d. Remove the existing roof sheathing and replace with new structural wood panel (plywood or oriented strand board) sheathing.

- e. Add blocking and special nailing at boundaries of diaphragms and subdiaphragms.
 - f. Add in-plane shear transfer connections between the walls and roof.

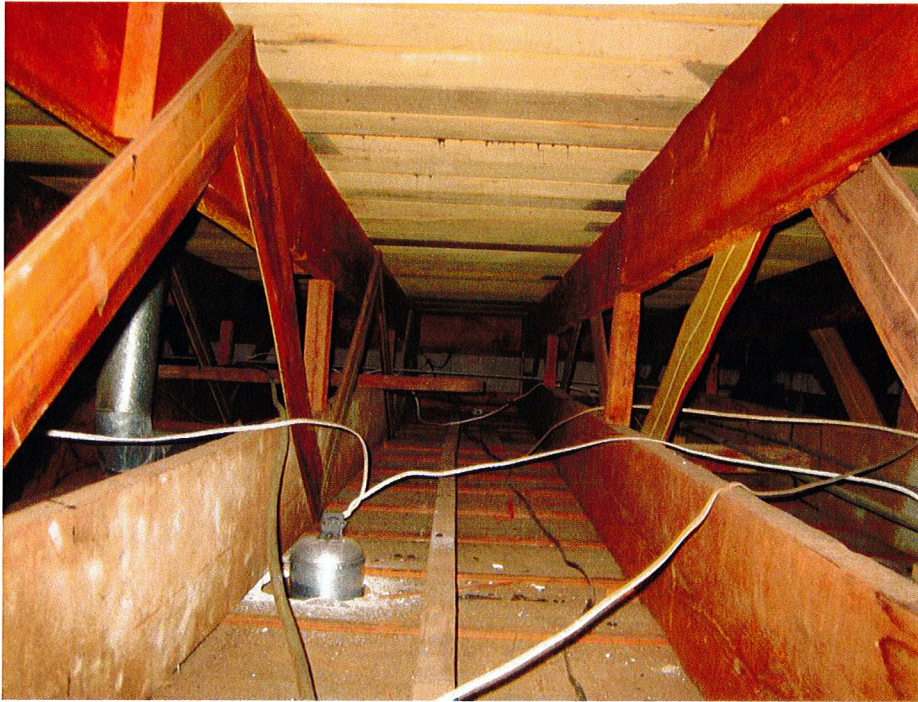
Roof Trusses in Rear Area

There were very few connections between the roof framing and wall in both portions of the building.

This lack of connection is a reason RM1 type buildings have performed poorly in past earthquakes. Connections between the walls and roof transfer the out-of-plane lateral forces into the roof diaphragm and the diaphragm distributes these forces to the vertical lateral force resisting elements. It is also necessary to have continuous cross ties (interconnected framing members in the roof) to keep the walls from separating from the roof. The steel beams in the Apparatus Room are the only continuous roof elements.

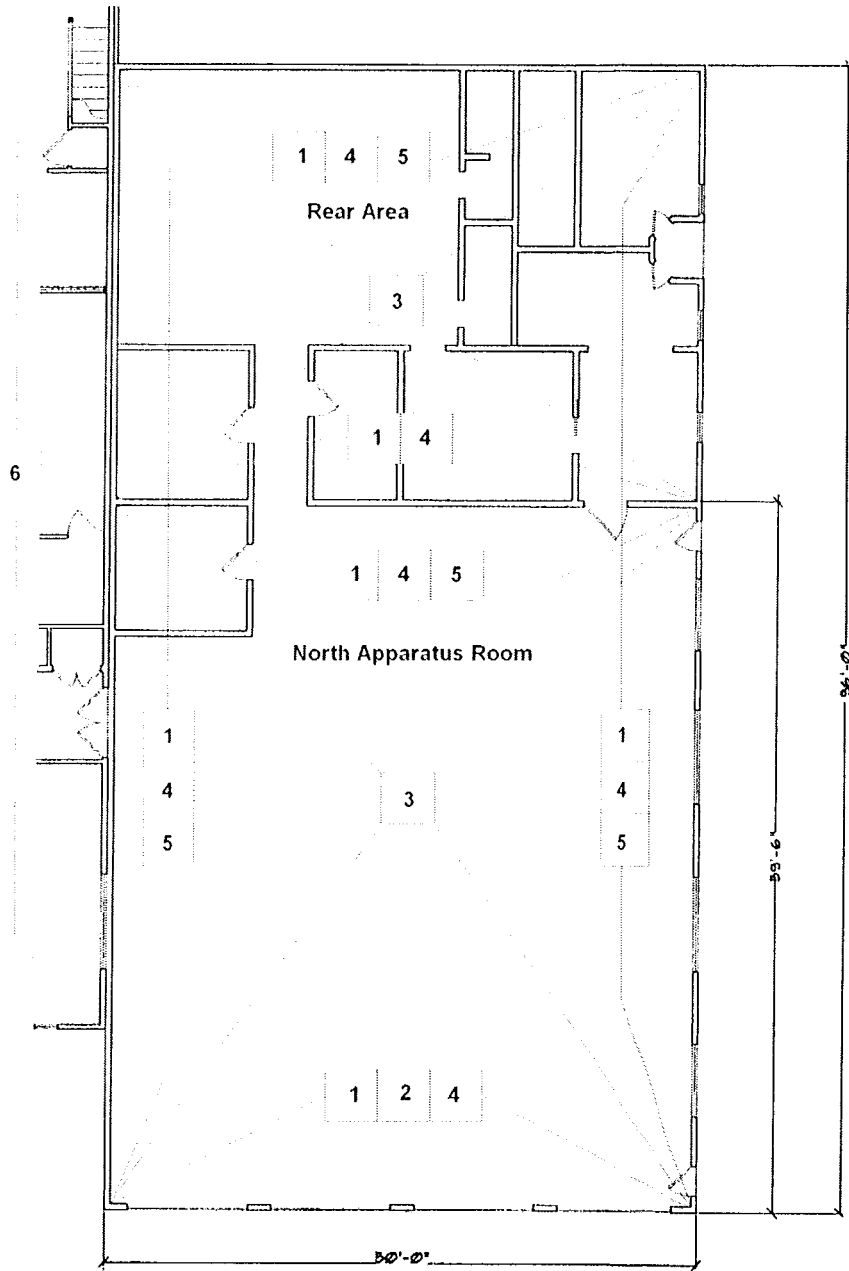
North Wing Potential Deficiencies

1. Inadequate out-of-plane ties between CMU walls and concrete frame and the roof. There is no positive connection between the walls and the roof diaphragm in the east-west direction (verified by observation). Steel girders connected to concrete column on the north and south walls of the North Apparatus Room provide a means of transferring load to the roof diaphragm. However, the framing on top of the steel beams is unsheathed and connections to the steel beam were not apparent. Ledger connections to the walls were not apparent. No other wall ties were observed. Cross ties are present in the north-south direction of the North Apparatus Room (steel girders approximately 14 feet on center). There are none in the east-west direction and there are no connections of roof framing to walls to transfer wall out-of-plane forces to the roof diaphragm. There are no cross ties in the rear area.

4. Inadequate in-plane shear transfer capacity between the roof diaphragm and CMU walls and concrete moment frame. Few connections between ledgers or edge members and shear walls were observed. Connections between the roof diaphragm boundary members and shear walls were not observed.

5. Inadequate in-plane shear capacity in CMU walls. The non-compliant statements from the Tier 1 checklists were based on the assumption that the walls were likely to have minimal reinforcing and the walls have large openings. The wall reinforcing may also be inadequate to resist out-of-plane loads in bending.
6. No seismic separation with adjacent construction. The 1977 plan drawings show no gap between the north wall of the Offices and Crew's Rooms building and the concrete columns on the south wall of the North Apparatus Room. Drawings of 1997 addition show the new wood framing built up against the CMU walls. This condition was confirmed by observation.

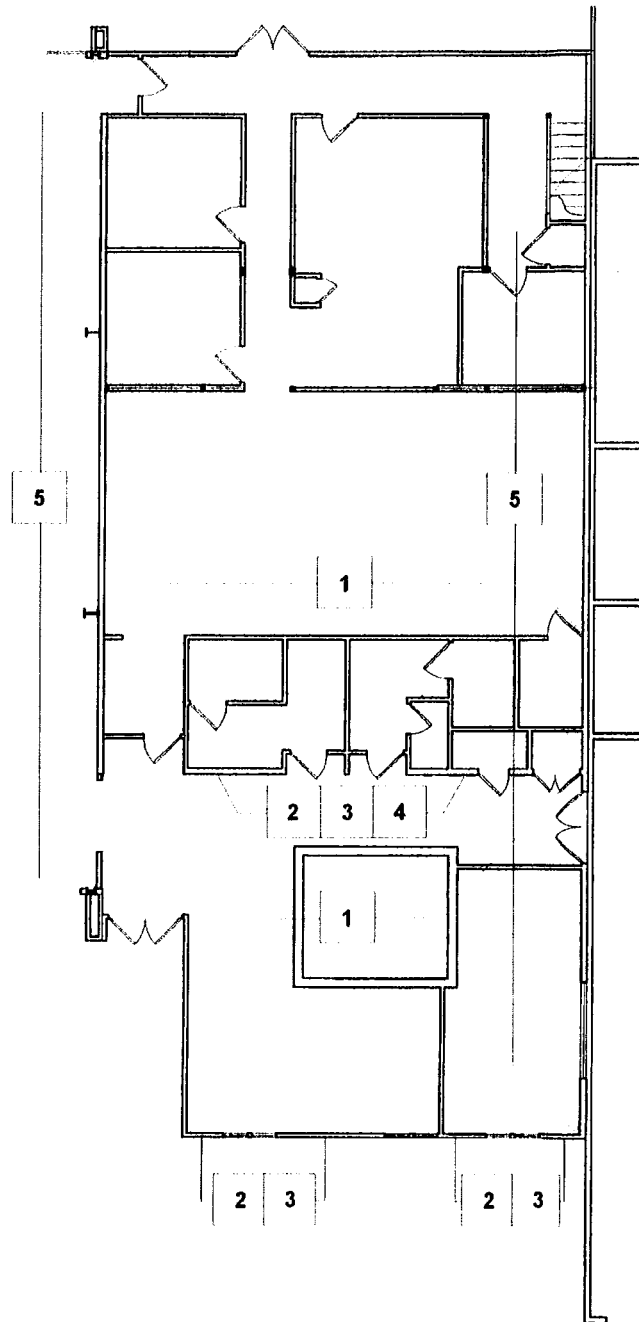
Offices and Crew's Rooms Potential Deficiencies

1. Both lines of north-south interior shear walls are not connected to the roof diaphragm. The 1977 construction drawings call for the interior shear wall on the through corridor to be extended to the roof. The wall does extend to the roof but the blocking between roof trusses is not connected to the wall. The 1997 construction added another wall to the west, we assume to compensate for removing some of the existing wall on the through corridor. There was no detail showing this new wall's connection to the roof. The wall does not extend above the bottom of the trusses and there are no panels or infill between trusses to transfer forces from the roof to the top of the wall.

2. The 1977 construction likely lacks foundation hold-downs at the ends of shear walls. The foundation plan and details and the framing plans and sections do not show hold-downs at the ends of plywood sheathed shear walls. Based on our analysis, the shear walls at the front of the building and the interior shear walls on the west side of the north-south through corridor require hold-downs.

3. The 1977 construction likely lacks sufficient anchor bolts at shear walls. The 1977 and 1997 drawings show anchor bolts in walls at 4 feet on center. Based on our analysis, the shear walls at the front of the building and the interior shear walls on the north-south through corridor do not have the required anchor bolts to transfer the wall shear to the foundation.

4. The interior shear walls on the north-south through corridor do not have adequate shear capacity.
5. There are no seismic separations between this and the two adjacent buildings. The north wall of the Offices and Crew's Rooms are built against the south wall of the North Wing. The roof diaphragm of the one story portion abuts the south wall of the North Wing. The buildings will move laterally in an earthquake and may impact each other and create additional loads in the structure and possible damage. The south wall is common to both the Offices and Crew's Rooms and the South Wing and poses a similar problem.

1. Connect the two north-south interior shear walls to the roof diaphragm. These repairs address deficiency 1. Work scope items are
 - a. Add plywood sheathed blocking panels between existing roof trusses above the east wall of the Meeting Room/Day Room. Nail the roof sheathing to the top of the blocking panels.

- b. Connect the walls to the existing blocking on the west side of the north-south through corridor. Nail the roof sheathing to the blocking.
2. Add hold-downs on the ends of four shear walls on the east exterior wall and two shear walls on the west side of the north-south through corridor. These repairs address deficiency 2.

3. Add epoxy anchors in the sill plates of four shear walls on the east exterior wall and two shear walls on the west side of the north-south through corridor. These repairs address deficiency 3.

4. Add edge nailing to the two shear walls on the west side of the north-south through corridor. This repair addresses deficiency 4.
5. Provide seismic separations from the adjacent buildings at the roof level (1 story portion) and the second floor level (2 story portion).

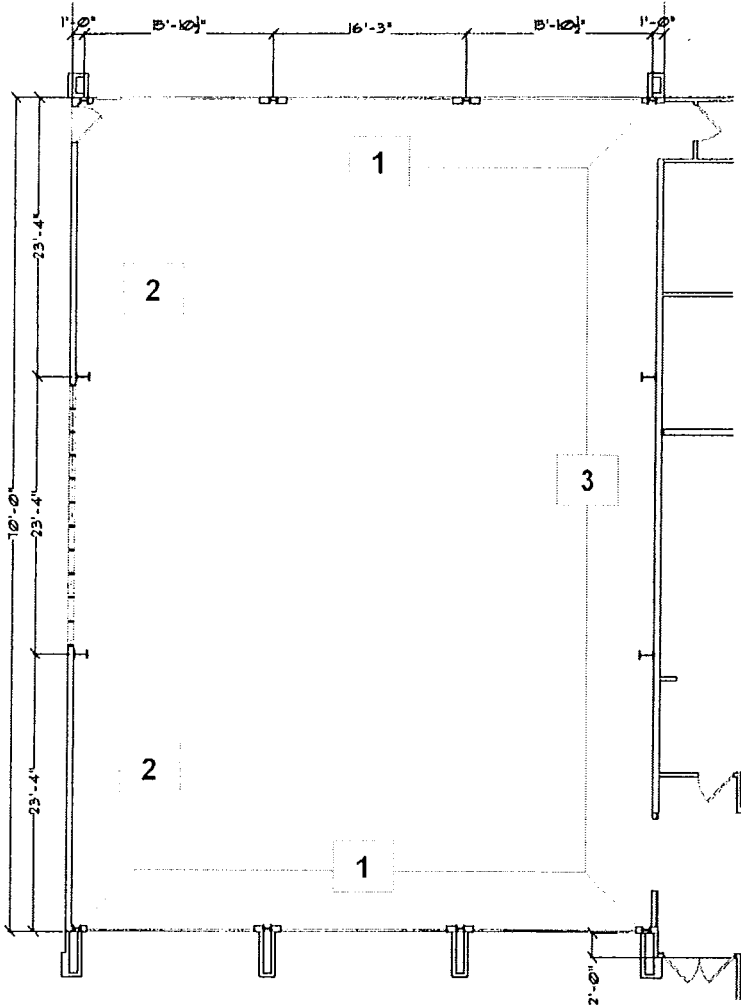
South Wing Potential Deficiencies

1. The steel gravity frames on the east and west elevations may permanently deform and block egress from the building.
2. The plywood sheathed wall segments on the south side require hold-downs at the ends.
3. There is no seismic separation between the South Wing and the Offices and Crew's Rooms building.

1. Weld cover plates on the east and west steel frame columns to create box sections. Separate the wood framing from the columns and reframe the wood sheathed enclosure around the column and make the support for the roll up doors independent from the steel frame. These repairs address deficiency 1.
2. Add hold-downs on the ends of the two shear wall segments on the south wall. This repair addresses deficiency 2.
3. Provide a seismic separation at the north wall. These repairs along with the repair in the Offices and Crew's Rooms building address deficiency 3.
 - a. Block out the wood framed wall at the interior frame columns.
 - b. Add hold-down at the ends of the remaining shear wall segments.

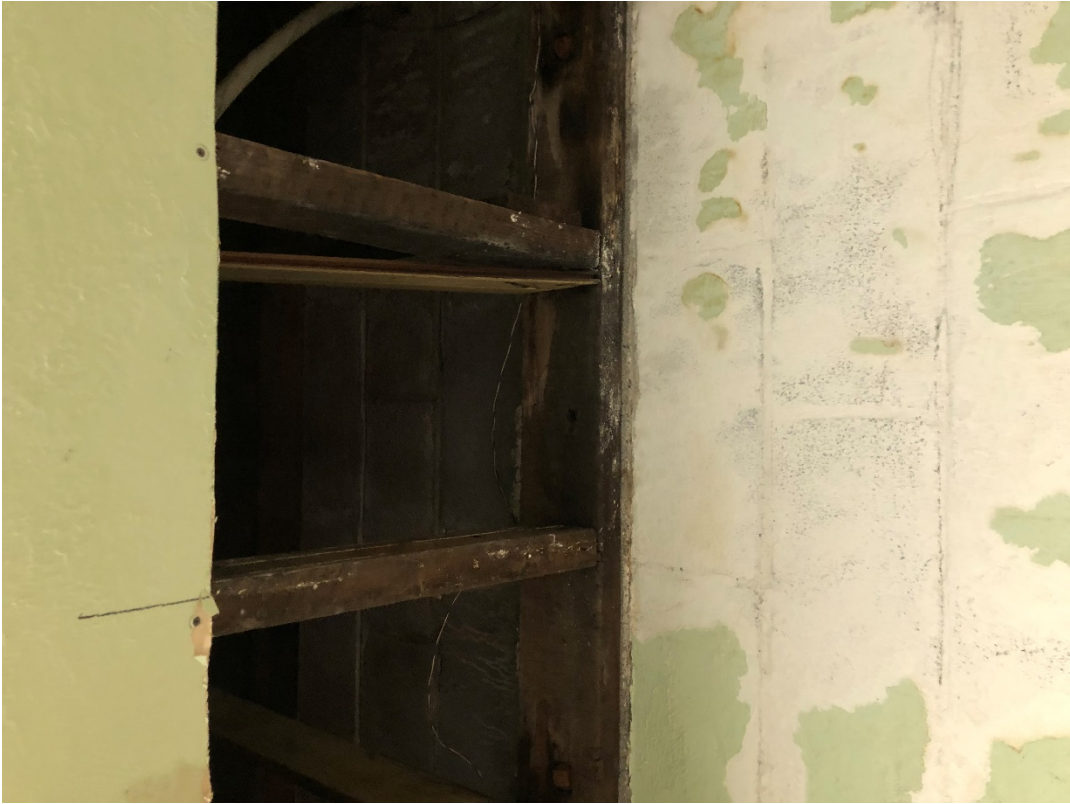
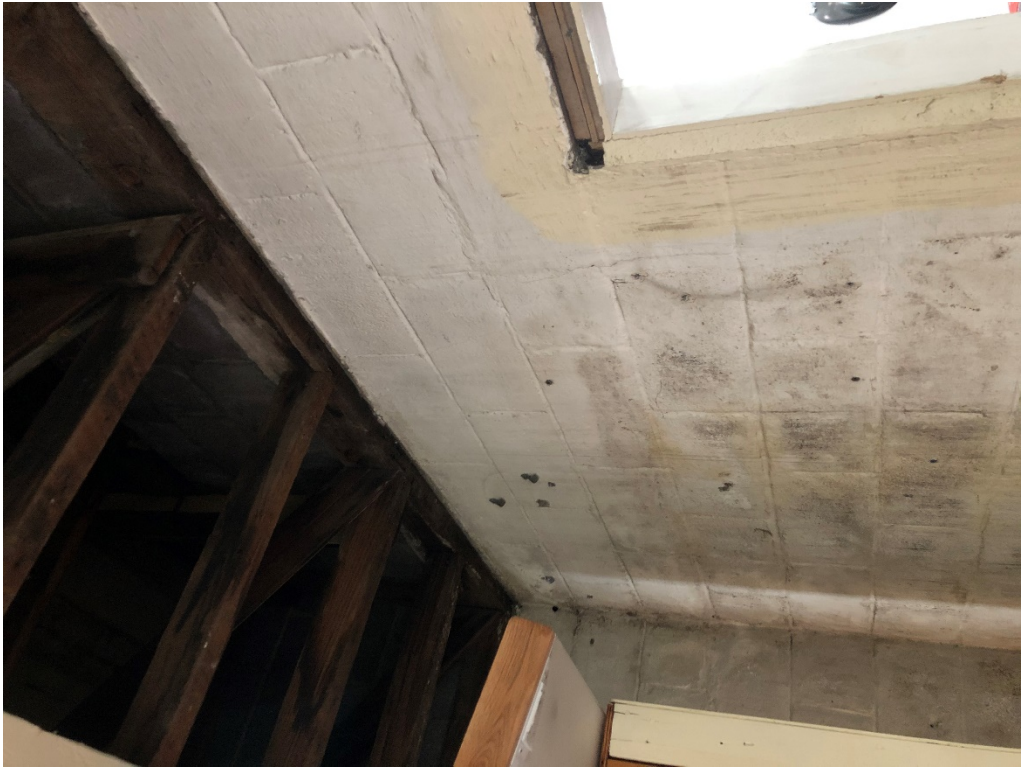
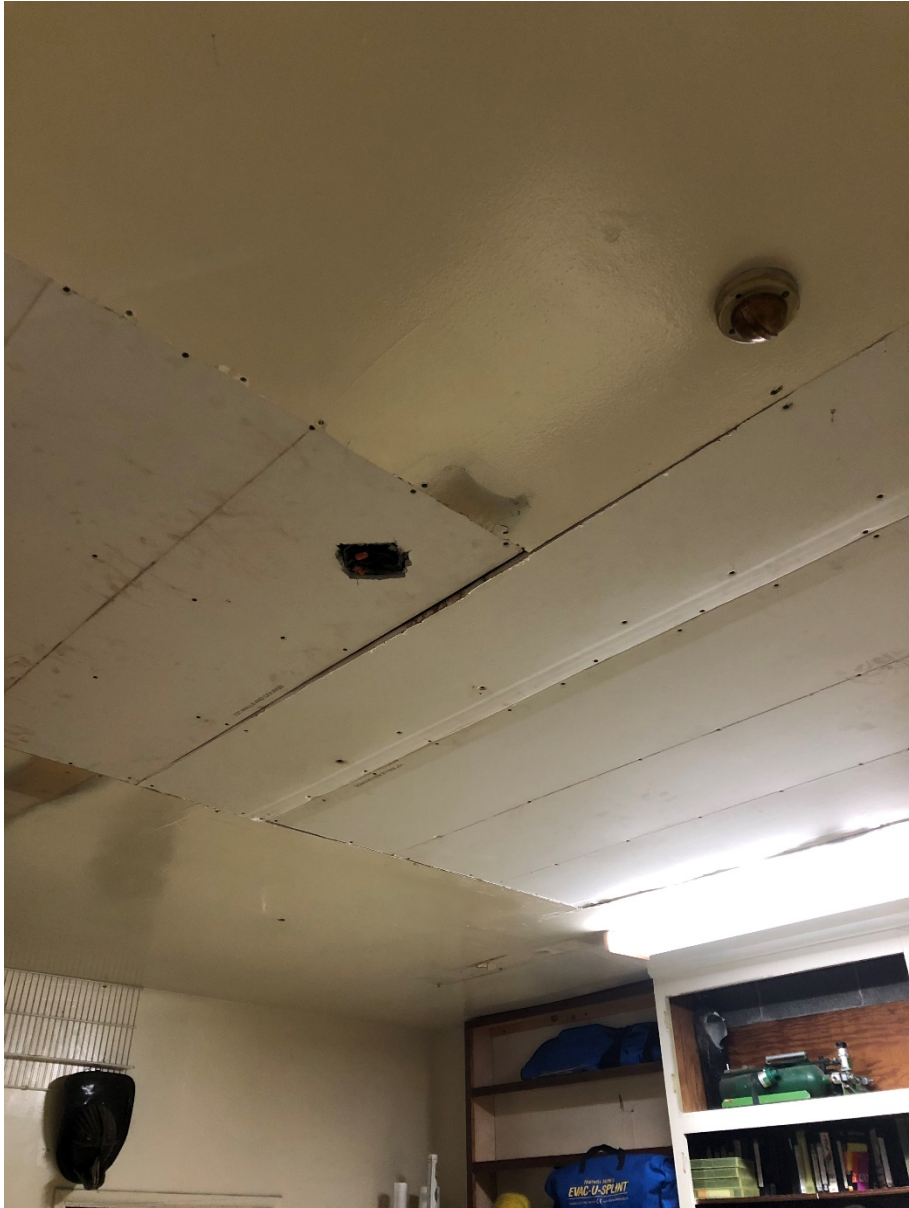
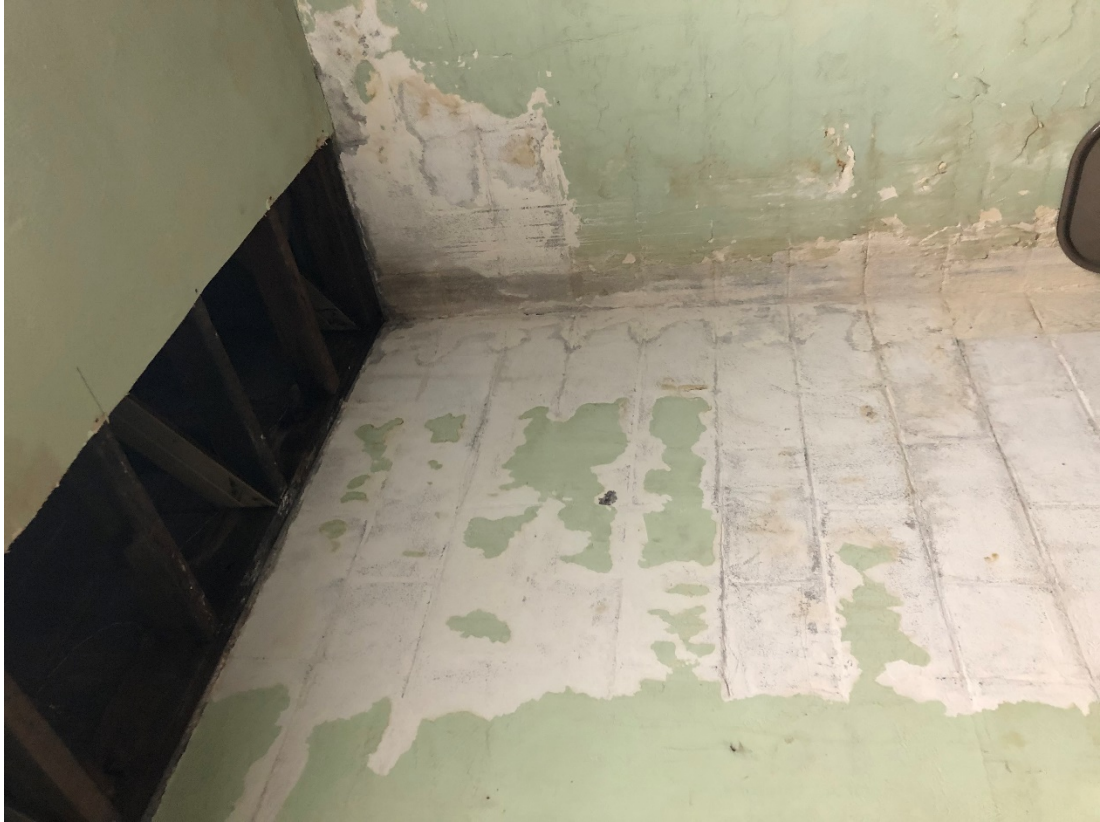
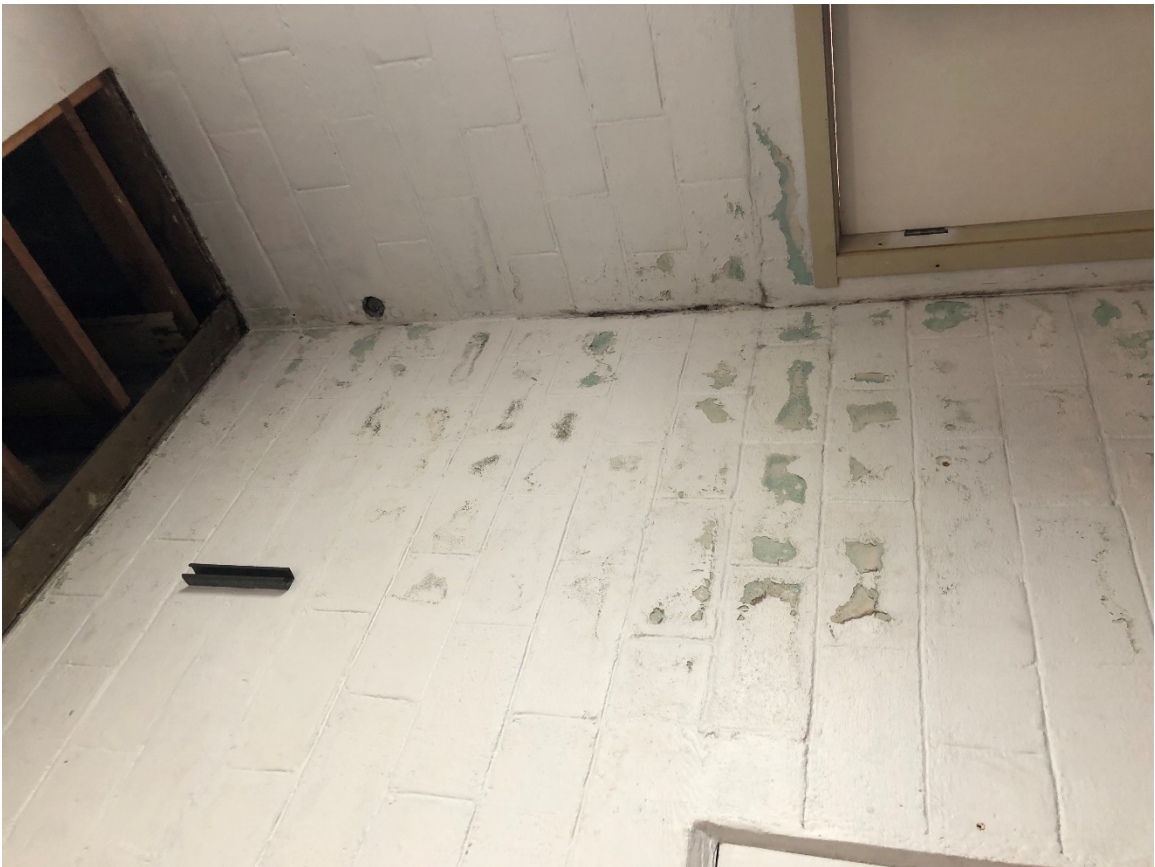
Fort Bragg Fire Station: Visual Deterioration/Damage from leaky roof
