CITY OF FORT BRAGG

MAIN STREET FIRE STATION SEISMIC EVALUATION

I.L. Welty & Associates
Fort Bragg, CA

June 29, 2009

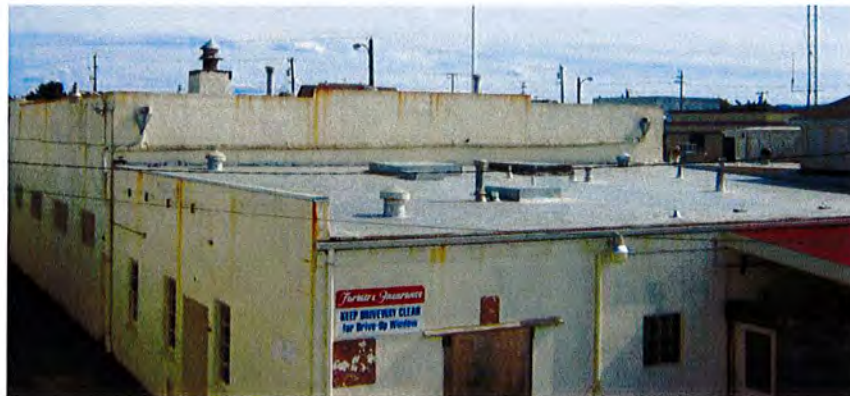
West Elevation

There are many openings in the masonry walls, especially on the north side of the building. As a result, the capacity of the walls to resist lateral forces is limited by the length of the full height segments and the reinforcing detailing around the wall openings. Resistance to lateral forces in the direction parallel to the wall will be concentrated in the longer, stiffer segments and reinforcing along the length of the wall is required to transfer or “collect” the forces generated in one portion of the building to the stiffer segments. On the north wall line for example, the longest wall segment is near the west end of the rear area. Based on its length, this segment should resist approximately half the lateral force on the line. However, collector reinforcing would have to be provided to account for the change in roof height between the building segments. If the collector element is lacking, the force in the narrow segments will be larger and may exceed the capacity of the wall.

These openings also affect the performance of the building when subjected to lateral loads out-of-plane. Resistance to seismic loads in the direction perpendicular to the walls is a special concern in RM1 buildings. Large inertial forces due to the mass of the masonry walls must be resisted by the walls in bending between supports at the roof and the foundation. We determined that a minimal amount of vertical wall reinforcing is needed to satisfy the out-of-plane load requirements specified in ASCE 31. The amount of reinforcing provided is more critical in walls with openings because resistance to out-of-plane forces are concentrated in the full height segments. More vertical reinforcing is required each side of openings to provide the necessary bending strength in the full height segments. Additional horizontal reinforcing is also required above and below the opening in the wall to provide the strength for these segments to span between the full height segments. Lacking original construction documents and given the age of the building, a program of nondestructive testing would be required to determine the amount and distribution of vertical and horizontal reinforcing that is in the walls. We did not perform this testing because both the 1977 and 1997 project drawings indicate the city plans to demolish the North Wing and replace it with a new structure in the future. We mention the need for testing because it should be considered in any plan to rehabilitate the North Wing.

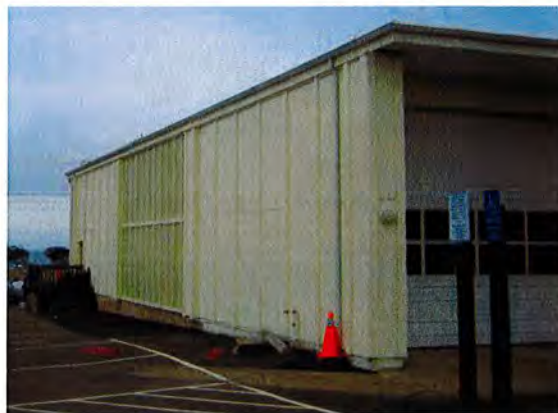
The north wall appears to be sheathed with plywood most of its length. It is a common structural element of the South Wing and the Offices and Crew's Rooms. Two segments of the south wall are sheathed with plywood. The length of sheathed segments is approximately two thirds the total wall length. The north and south walls have steel rod bracing in one frame bay. The roof diaphragm is plywood sheathing on wood joists that span between the steel frames. Based on our evaluation of the building, the following are potential deficiencies that would need to be resolved to satisfy the criteria for the Immediate Occupancy level of performance:
