CITY OF FORT BRAGG PUBLIC FACILITIES MASTER PLAN

Grossmann Design Group

March 6, 2007

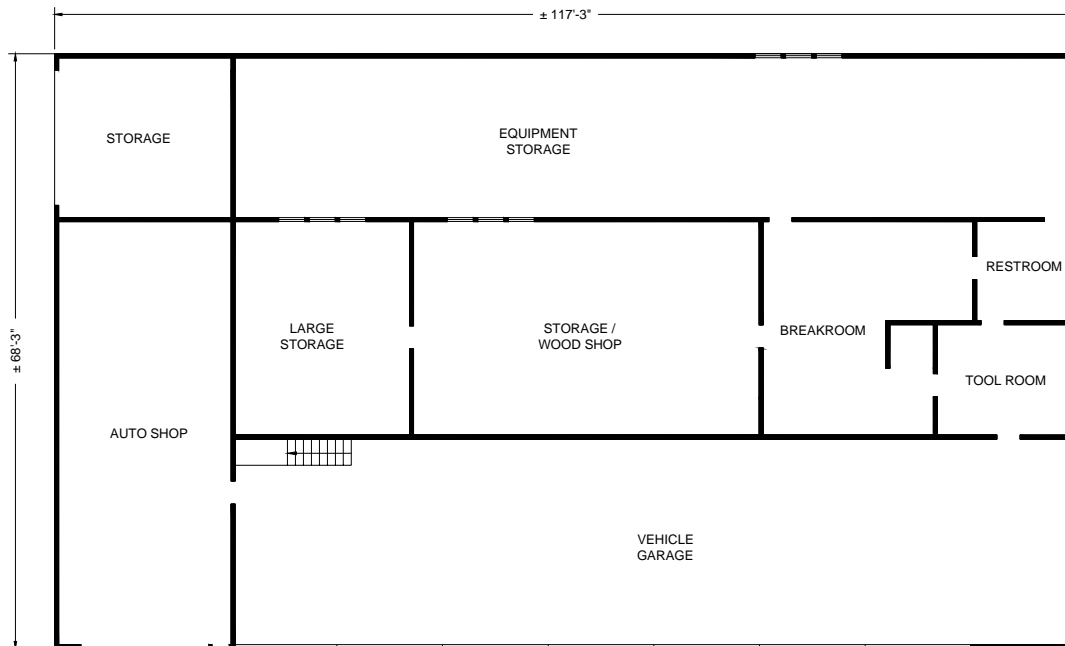
FLOOR PLAN

grader, a backhoe, trucks, and lifts owned by the City of Fort Bragg. Currently a grader, a backhoe, trucks, and lifts are not parked in a weatherproof enclosure which results in premature deterioration of their components. The Fort Bragg climate is considered a coastal climate, and the failure to protect vehicles and equipment from moisture as described in the SERVICE AREA AND DEMAND FOR SERVICES section customarily reduces the Useful Service Life of vehicles and equipment.

The facilities master plan includes a schedule of exterior and interior maintenance work, but replacement of the corporation yard building is recommended. Facility maintenance should be limited to repairs and maintenance deemed essential to operate the corporation facilities for a short period of time until the construction of new corporation yard facilities is complete. If the corporation yard facilities are not replaced as recommended by the consultant, life and safety facility deficiencies require the immediate attention of the City of Fort Bragg.

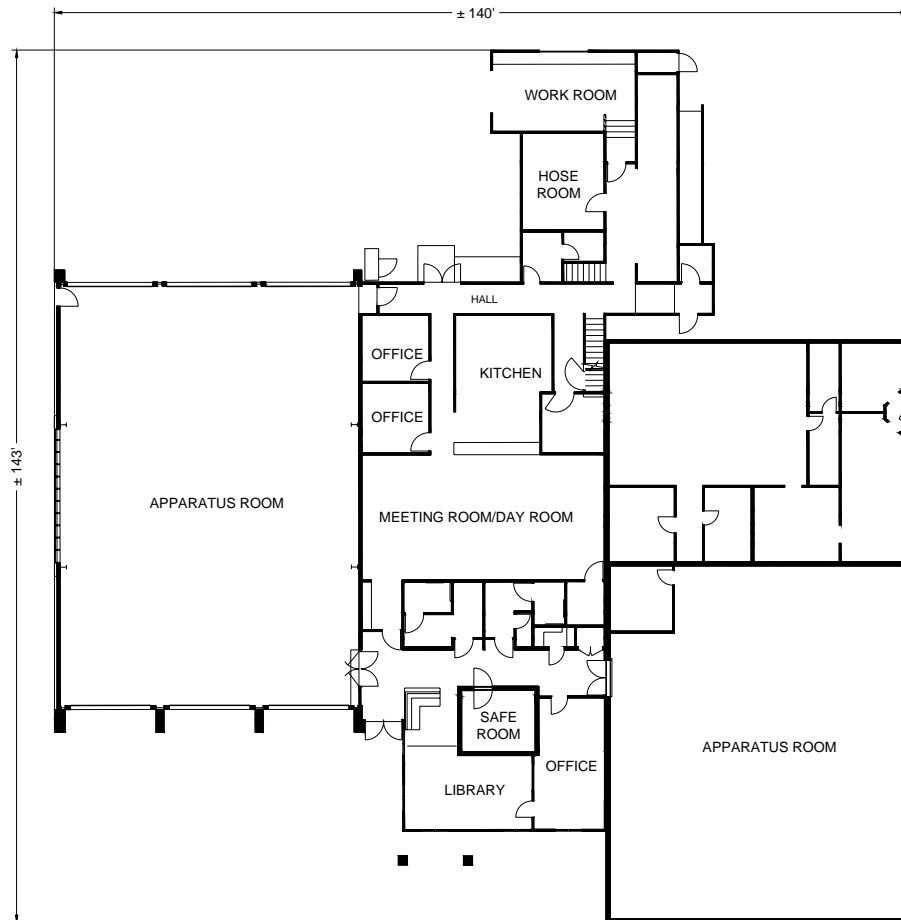
FLOOR PLAN

Immediate Occupancy criteria as defined by ASCE-31 “Seismic Evaluation of Existing Buildings”. Both constructions meet the ASCE-31 “Seismic Evaluation of Existing Buildings” Benchmark Buildings criteria for Immediate Occupancy Performance Level, with the following exceptions:

- ▶ The 1977 construction likely lacks foundation hold-downs at the ends of shear walls.
- ▶ The 1977 construction likely lacks sufficient anchor bolts at shear walls.
- ▶ There are no seismic separations between either construction and the North and South Wings.
