CITY OF FORT BRAGG

MAIN STREET FIRE STATION SEISMIC EVALUATION

I.L. Welty & Associates
Fort Bragg, CA

June 29, 2009

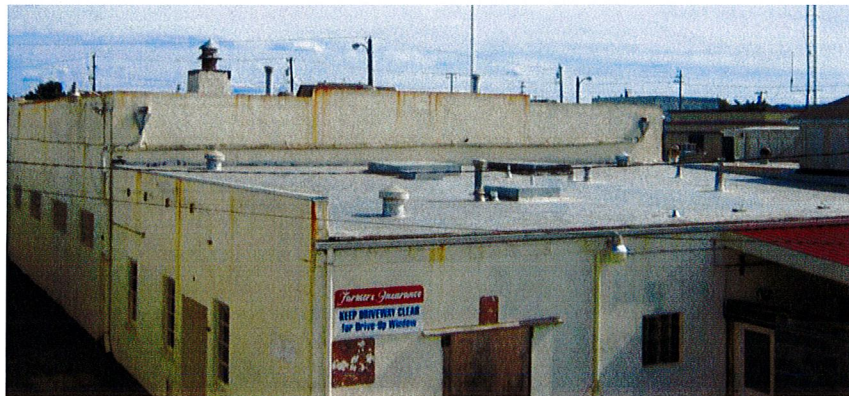
West Elevation

There are many openings in the masonry walls, especially on the north side of the building. As a result, the capacity of the walls to resist lateral forces is limited by the length of the full height segments and the reinforcing detailing around the wall openings. Resistance to lateral forces in the direction parallel to the wall will be concentrated in the longer, stiffer segments and reinforcing along the length of the wall is required to transfer or “collect” the forces generated in one portion of the building to the stiffer segments. On the north wall line for example, the longest wall segment is near the west end of the rear area. Based on its length, this segment should resist approximately half the lateral force on the line. However, collector reinforcing would have to be provided to account for the change in roof height between the building segments. If the collector element is lacking, the force in the narrow segments will be larger and may exceed the capacity of the wall.

These openings also affect the performance of the building when subjected to lateral loads out-of-plane. Resistance to seismic loads in the direction perpendicular to the walls is a special concern in RM1 buildings. Large inertial forces due to the mass of the masonry walls must be resisted by the walls in bending between supports at the roof and the foundation. We determined that a minimal amount of vertical wall reinforcing is needed to satisfy the out-of-plane load requirements specified in ASCE 31. The amount of reinforcing provided is more critical in walls with openings because resistance to out-of-plane forces are concentrated in the full height segments. More vertical reinforcing is required each side of openings to provide the necessary bending strength in the full height segments. Additional horizontal reinforcing is also required above and below the opening in the wall to provide the strength for these segments to span between the full height segments. Lacking original construction documents and given the age of the building, a program of nondestructive testing would be required to determine the amount and distribution of vertical and horizontal reinforcing that is in the walls. We did not perform this testing because both the 1977 and 1997 project drawings indicate the city plans to demolish the North Wing and replace it with a new structure in the future. We mention the need for testing because it should be considered in any plan to rehabilitate the North Wing.

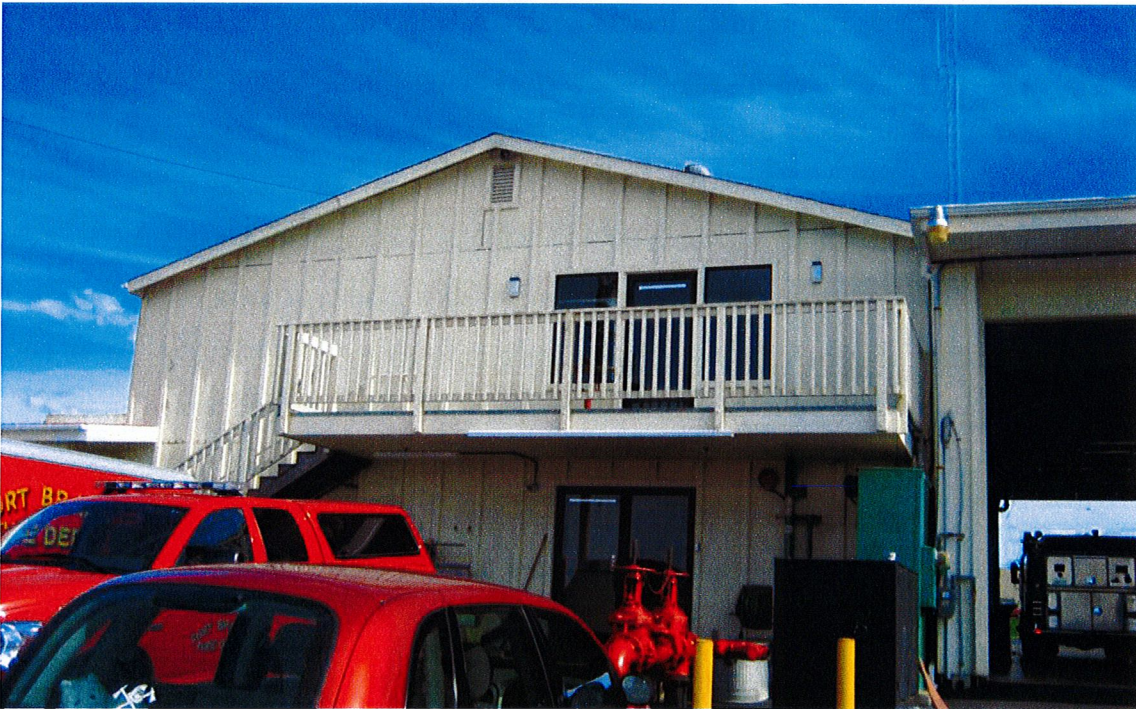
Offices and Crew's Rooms West Elevation

It contains a kitchen and offices on the first floor and a dormitory and exercise room on the second floor. It was constructed in 1997 according to the available drawings (Taubold 1997). Based on our evaluation of the building, the following are potential deficiencies that would need to be resolved to satisfy the criteria for the Immediate Occupancy level of performance:

2. The 1977 construction likely lacks foundation hold-downs at the ends of shear walls. The foundation plan and details and the framing plans and sections do not show hold-downs at the ends of plywood sheathed shear walls. Based on our analysis, the shear walls at the front of the building and the interior shear walls on the west side of the north-south through corridor require hold-downs.

3. The 1977 construction likely lacks sufficient anchor bolts at shear walls. The 1977 and 1997 drawings show anchor bolts in walls at 4 feet on center. Based on our analysis, the shear walls at the front of the building and the interior shear walls on the north-south through corridor do not have the required anchor bolts to transfer the wall shear to the foundation.

4. The interior shear walls on the north-south through corridor do not have adequate shear capacity.
5. There are no seismic separations between this and the two adjacent buildings. The north wall of the Offices and Crew's Rooms are built against the south wall of the North Wing. The roof diaphragm of the one story portion abuts the south wall of the North Wing. The buildings will move laterally in an earthquake and may impact each other and create additional loads in the structure and possible damage. The south wall is common to both the Offices and Crew's Rooms and the South Wing and poses a similar problem.

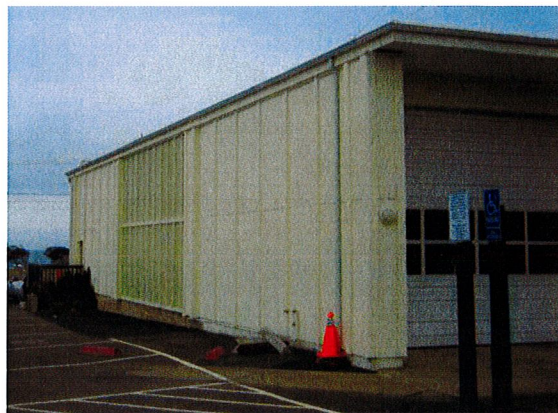
The north wall appears to be sheathed with plywood most of its length. It is a common structural element of the South Wing and the Offices and Crew's Rooms. Two segments of the south wall are sheathed with plywood. The length of sheathed segments is approximately two thirds the total wall length. The north and south walls have steel rod bracing in one frame bay. The roof diaphragm is plywood sheathing on wood joists that span between the steel frames. Based on our evaluation of the building, the following are potential deficiencies that would need to be resolved to satisfy the criteria for the Immediate Occupancy level of performance:
